## D3.5\_Report on step-by-step retrofitting building case studies

### Project: CS03 - Hotel Restaurant Valcanover

#### EuroPHit

[Improving the energy performance of step-by-step refurbishment and integration of renewable energies]

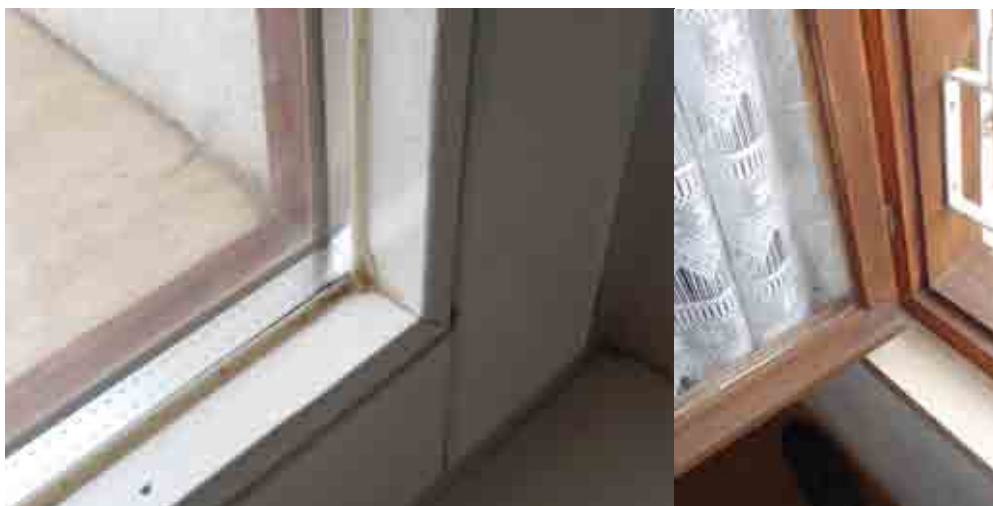
Description : Double glazed and single glazed windows with wooden frame  
 U-Value [W/(m<sup>2</sup>K)] : 3.088 W/m<sup>2</sup>K (average)  
 Installation date : 1928, 1980, 1994, 2008  
 Condition : Poor  
 Next replacement : 2015  
 Other :

Figure 5: Existing double glazed (left) and single glazed (right) windows [ZEPHIR 2013].

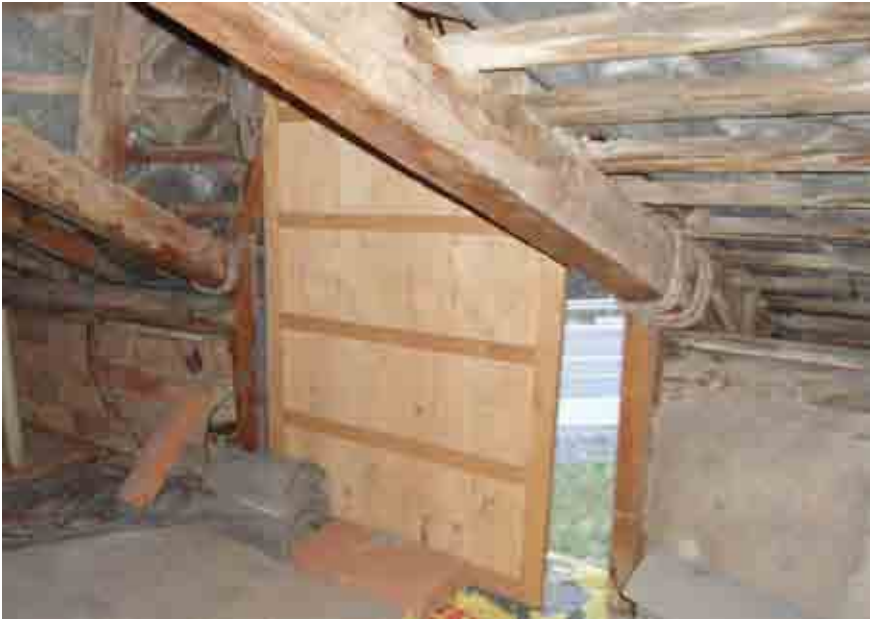
Description : Lightweight timber construction  
 U-Value [W/(m<sup>2</sup>K)] : 1.917 W/m<sup>2</sup>K  
 Installation date : 1928  
 Condition : End of lifecycle  
 Next replacement : 2015  
 Other :

Figure 6: Roof of the existing building [ZEPHIR 2013].

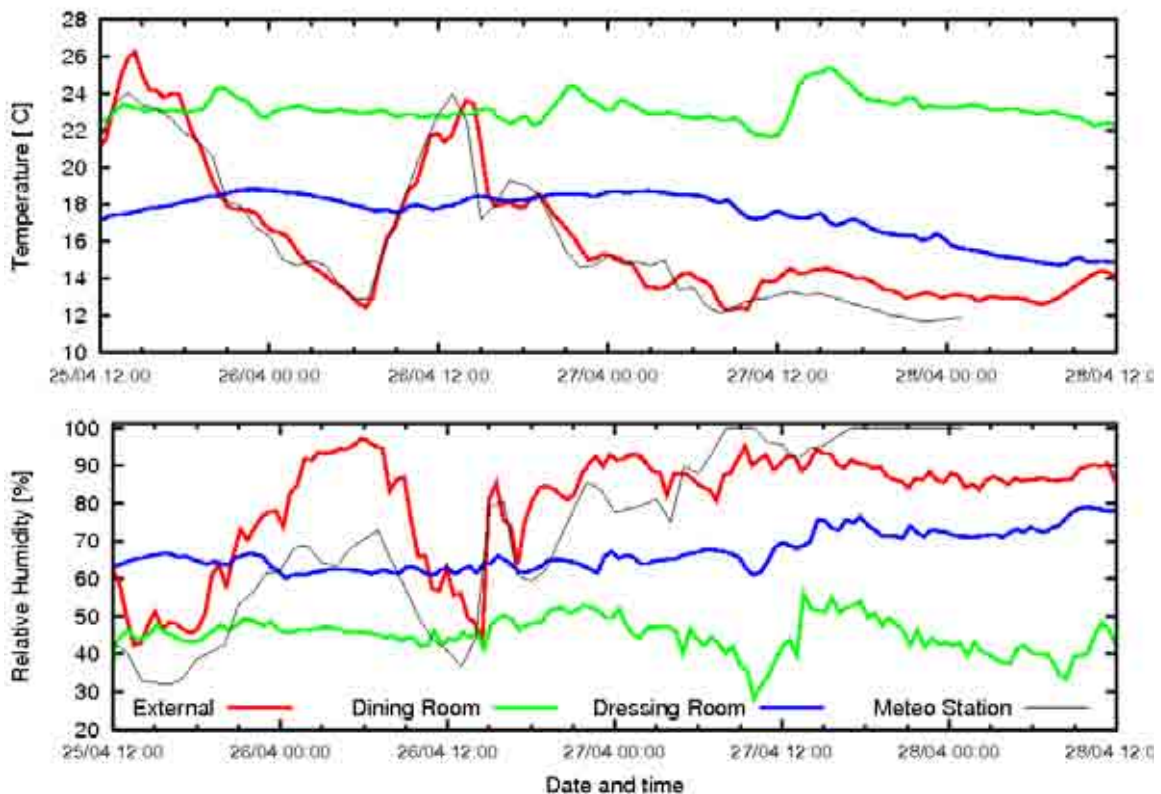
Figure 35: Sample plot of the results extracted from the three sensors (blue line: dressing room, green line: dining room, red line: external). Top panel: air temperature. Bottom panel: relative humidity.

- The time constant of the building is extremely low and therefore the climatic parameters quickly respond to the external climatic condition. As a result even short periods with low temperatures result in high energy consumptions for space heating.

- The relative humidity in the dining room is too high. To guarantee living comfort it should be in the range 30 - 50%, while from the measured data we have relative humidities outside this range. This demonstrates that a ventilation concept based on natural ventilation is not enough. It is therefore important to install in the refurbished building a mechanical ventilation system with heat recovery.
