D3.9_Overall Refurbishment Plan

CS02

School, RosMuc

EuroPHit

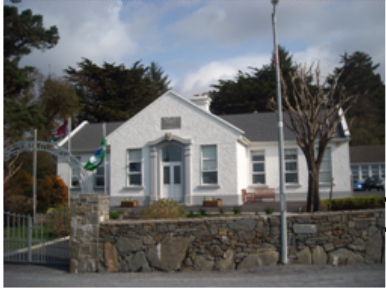
Figure 5: Specific energy efficiency values of the existing building modelled with PHPP 9 Beta

Building:	Gairmscoil Na Bpiaisach-Main Building		
		Street:	Rosmuc, Galway		
		Postcode/City:	Galway		
		Country:	Ireland		
		Building type:	School		
		Climate:	[IE] - Brrr		
		Altitude of building site (in [m] above sea level): -			
		Home owner/client:	VEC		
		Street:			
		Postcode/City:			
Architecture:			Mechanical System:		
Street:			Street:		
Postcode/City:			Postcode/City:		
Energy consulting:			Certification:		
Street:			Street:		
Postcode/City:			Postcode/City:		
Year of Construction:	1945	Interior temperature winter [C°]	19.0	Interior temp. summer [C°]	25.0
Number of dwelling units:	1	Internal heat gains winter [W/m²]	2.8	IHG summer [W/m²]	2.8
Number of Occupants:	11.0	Spec. capacity [Wh/K per m² TFA]			132
Exterior vol. V _e :	1709.3 m³	Mechanical cooling:

Specific building demands with reference to the treated floor area			
		Treated floor area	383.7 m²
Space heating	Annual heating demand	316 kWh/(m²a)	25 kWh/(m²a)
	Heating load	102 W/m²	-
Space cooling	Overall specific space cooling demand	kWh/(m²a)	-
	Cooling load	W/m²	-
	Frequency of overheating (> 25 °C)	0.0 %	-
Primary Energy	Heating, cooling, dehumidifying, DHW,	418 kWh/(m²a)	481 kWh/(m²a)
	DHW, space heating and auxiliary electricity	399 kWh/(m²a)	-
	Specific primary energy reduction through solar electricity	kWh/(m²a)	-
Airtightness	Pressurization test result n ₅₀	10.0 1/h	1 1/h

The energy efficiency properties of the existing buildings were calculated with the use of the PHPP (Passive House Planning Package) and the results prove that the energy performance of the buildings is very poor due mainly to the lack of insulation in the thermal envelope. The following results are average calculation between the three blocks

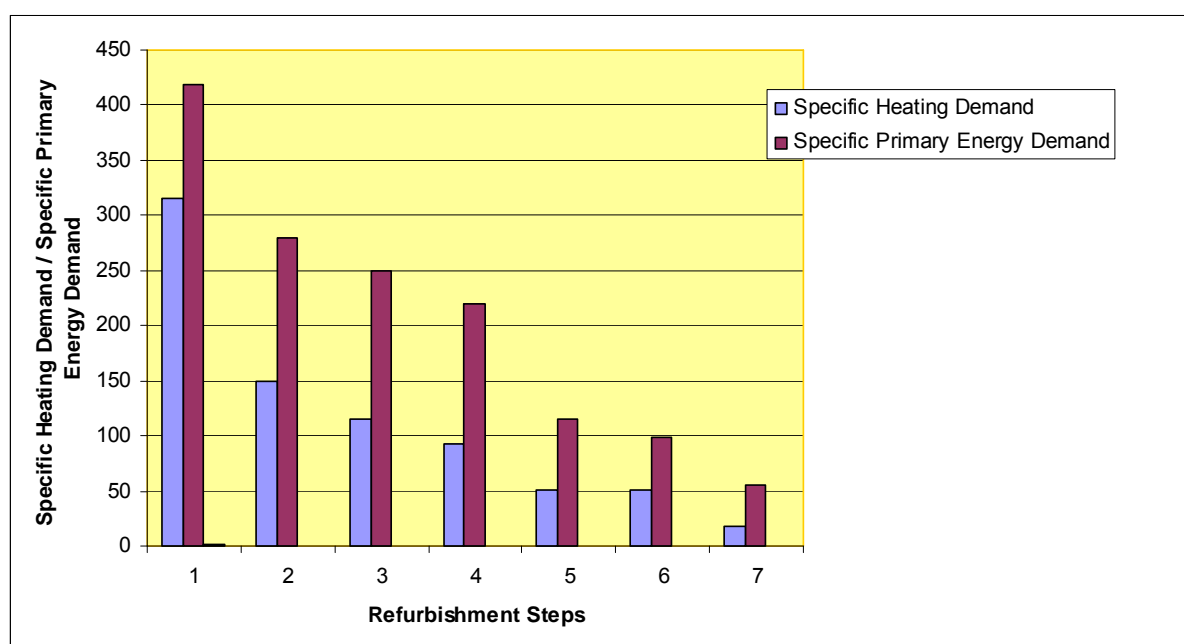
Figure 11: Overview energy efficiency improvement according to the overall refurbishment plan

Step No.	Year	Measures	Specific Heating Demand	Specific Primary Energy Demand
-	1945 - 1960	Existing Buildings	316	418
1	2015	New Roof to Main Building & Metalwork Block, 4 new Classrooms	150	280
2	2016	External walls refurbished to all existing buildings and new roof to Classroom/Office. New Classrooms Built.	115	250
3	2016	Replacement of windows & doors	93	220
4	2016	Airtightness to 1 air changes per hour @ 50 Pa & MHRV installed	51	115
5	2016	Condensing Gas Boiler & new radiators installed	51	98
6	2018	Enclosure of central space to Passive House standard	18	55

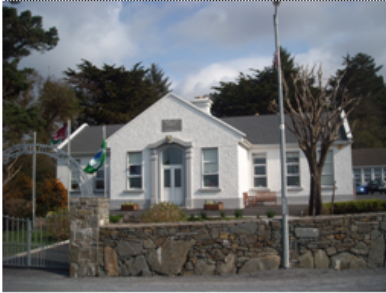
Building:	Gairmscoil Na Bpiaisach-Main Building		
		Street:	Rosmuc, Galway		
		Postcode/City:	Galway		
		Country:	Ireland		
		Building type:	School		
		Climate:	[IE] - Brrr		
		Altitude of building site (in [m] above sea level): -			
		Home owner/client:	VEC		
		Street:			
		Postcode/City:			
Architecture:		Mechanical System:			
Street:		Street:			
Postcode/City:		Postcode/City:			
Energy consulting:		Certification:			
Street:		Street:			
Postcode/City:		Postcode/City:			
Year of Construction:	1945	Interior temperature winter [C°]	19.0	Interior temp. summer [C°]	25.0
Number of dwelling units:	1	Internal heat gains winter [W/m²]	2.8	IHG summer [W/m²]	2.8
Number of Occupants:	11.0	Spec. capacity [Wh/K per m² TFA]			132
Exterior vol. V _e :	1709.3 m³	Mechanical cooling:

Specific building demands with reference to the treated floor area				
		Treated floor area	Requirements	Fulfilled?*
Space heating	Annual heating demand	76 kWh/(m²a)	25 kWh/(m²a)	no
	Heating load	25 W/m²	-	-
	Overall specific space cooling demand	kWh/(m²a)	-	-
Space cooling	Cooling load	W/m²	-	-
	Frequency of overheating (> 25 °C)	0.0 %	-	-
	Primary Energy	Heating, cooling, dehumidifying, DHW,	129 kWh/(m²a)	193 kWh/(m²a)
DHW, space heating and auxiliary electricity		110 kWh/(m²a)	-	-
Specific primary energy reduction through solar electricity		kWh/(m²a)	-	-
Airtightness	Pressurization test result n ₅₀	1.0 1/h	1 1/h	yes

Figure 12: Specific energy efficiency values after measures within EuroPHit

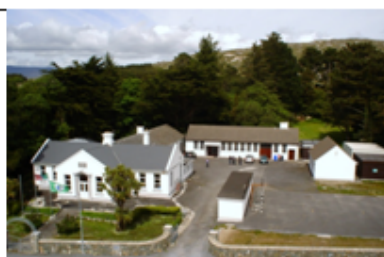
Building:	Gairmscoil Na Bpiaisach-Proposal		
Street:	Rosmuc, Galway		
Postcode / City:	Galway		
Country:	Ireland		
Building type:	School		
Climate:	[IE] - Brrr	Altitude of building site (in [m] above sea level):	-
Home owner / Client:	VEC		
Street:			
Postcode / City:			
Architecture:			
Street:			
Postcode / City:			
Mechanical system:			
Street:			
Postcode / City:			
Year of construction:	2018	Interior temperature winter:	19.0 °C
No. of dwelling units:	1	Interior temperature summer:	25.0 °C
No. of occupants:	33.8	Internal heat sources winter:	2.8 W/m²
Spec. capacity:	132	Ditto summer:	2.8 W/m²
	Wh/K per m² TFA		
		Enclosed volume V, m³:	6834.6
		Mechanical cooling:

Treated floor area	1184.7 m²	Requirements	Fulfilled?*
Space heating	Heating demand	18 kWh/(m²a)	25 kWh/(m²a)	yes
	Heating load	11 W/m²	-	-
Space cooling	Overall specif. space cooling demand	kWh/(m²a)	-	-
	Cooling load	W/m²	-	-
	Frequency of overheating (> 25 °C)	0.1 %	-	-
Primary energy	Heating, cooling, dehumidification, DHW, auxiliary electricity, lighting, electrical appliances	56 kWh/(m²a)	124 kWh/(m²a)	yes
	DHW, space heating and auxiliary electricity	56 kWh/(m²a)	-	-
	Specific primary energy reduction through solar electricity	kWh/(m²a)	-	-
Airtightness	Pressurization test result n ₅₀	0.6 1/h	1 1/h	yes

Figure 20: Specific energy efficiency values of the completed project modelled with PHPP

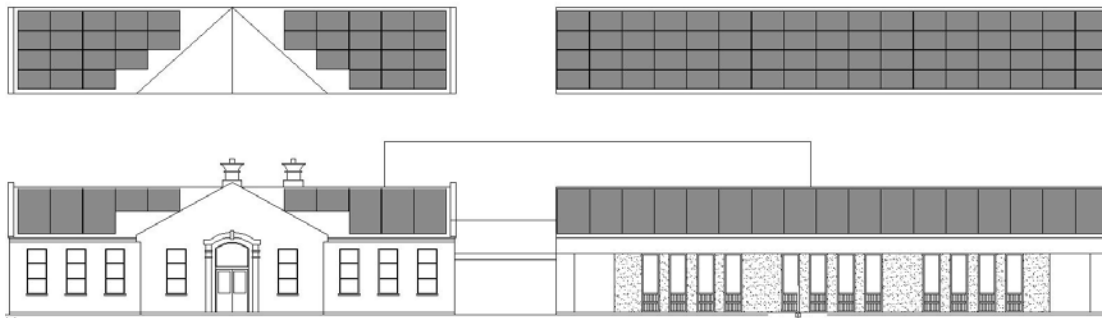
Figure 3: Rooftop and south façade view

The best option for this building is the integration on the roof, taking advantage of this area directly exposed to the sun. PV tilted traditional panels could be a good intervention, but due to aesthetic criteria, the proposal is based on the superposition of the panels with a black back sheet parallel to the existing roof. Thus, the visual impact from the street remains unchanged.

Furthermore, the application of insulating material between the PV glass and the existing roof, can help to avoid thermal losses and to increase the inner comfort.

The roof superposition would be located on all the available area. The scheme of the PV integration is shown below:
