EuroPHit

D3.9_Overall Refurbishment Plan

CS15

André Tournon-sur-Rhône

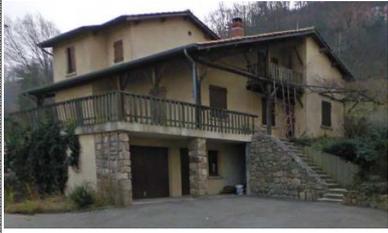
EnerPHit verification

For an overview of the energy efficiency of the existing building, see the verification spreadsheet of the PHPP 9 beta version [PHI 2013] on the next page.

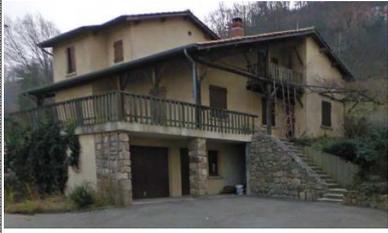
EnerPHit verification

For an overview of the energy efficiency of the completed step-by-step refurbishment, see the verification spreadsheet of the PHPP 9 beta version [PHI 2013] on the next page.
