CS14_Wilmcote House_United Kingdom

Author Steven Stenlund
BRE

1.3.1 Roof support thermal break

Date March 2015

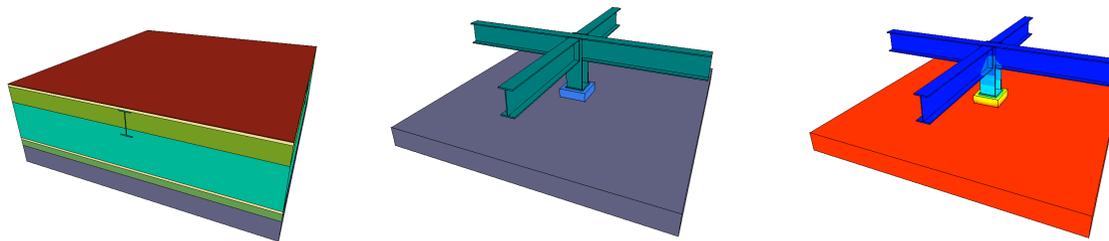
1.3.1 Roof support thermal break – Thermal model

χ -value = 0.056 W/K

No pre-refurbishment thermal modelling undertaken
