## **D3.9\_Overall Refurbishment Plan**

**CS10 Primary school “St.St. Kiril and Methodius”**

**Gabrovo**

**[Improving the energy performance of step-by-step refurbishment and integration of renewable energies]**

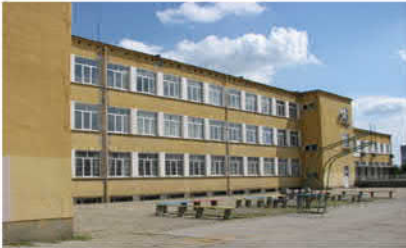
<table><tr> <th colspan="2"></th> <th>Treated floor area</th> <th>Requirements</th> <th>Fulfilled?*</th> <th></th> </tr><tr> <td rowspan="3">Space heating</td> <td>Annual heating demand</td> <td><b>142 kWh/(m²a)</b></td> <td>25 kWh/(m²a)</td> <td><b>no</b></td> <td rowspan="3">Space</td> </tr><tr> <td>Heating load</td> <td><b>66 W/m²</b></td> <td>-</td> <td>-</td> </tr><tr> <td rowspan="3">Primary Energy</td> <td>DHW, space heating and auxiliary electricity</td> <td><b>233 kWh/(m²a)</b></td> <td>273 kWh/(m²a)</td> <td><b>yes</b></td> <td rowspan="3">Primary</td> </tr></table>

Figure 5: Specific energy efficiency values of the existing building –blocks A,B,C modelled with PHPP 9 Beta, Blocks A,B,C

- Modelled specific heating demand:  
Blocks A, B,C 142,4 kWh/(m<sup>2</sup>a), Block D-228,4 kWh/(m<sup>2</sup>a)
- Modelled specific cooling demand / overheating frequency:  
Blocks A, B,C -7,9%, Block D 11,3%
- Modelled specific primary energy demand:  
Blocks A, B,C 233,5 kWh/(m<sup>2</sup>a) , Block D - overheating

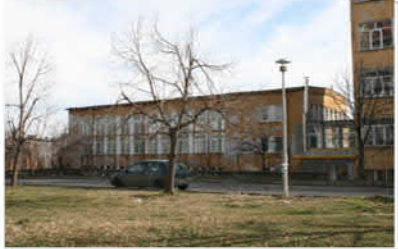
Building: Primary School 8 "Sveti Sveti Kiril I"	
		Street: 69 Mogilov blv.	
		Postcode/City: Gabrovo	
		Country: Bulgaria	
		Building type: School	
Climate: Велико Търнов		Altitude of building site (in [m] above sea level): 426	
Home owner/client: Municipality of Gabrovo		Street: 3 Vazrazhdane square	
Postcode/City: Gabrovo			
Architecture:		Mechanical System:	
Street:		Street:	
Postcode/City:		Postcode/City:	
Certification:		Energy consulting:	
Street:		Street:	
Postcode/City:		Postcode/City:	
Interior temperature winter [C°]: 18,0		Interior temp. summer [C°]: 24,0	
Internal heat gains winter [W/m²]: 5,4		IHG summer [W/m²]: 5,4	
		Spec. capacity [Wh/K per m² TFA]: 204	
		Mechanical cooling:	
Year of Construction: 2014		Number of dwelling units: 1	
Number of Occupants: 60,0		Exterior vol. V <sub>e</sub> : 4180,4	
m³			
Reference to the treated floor area			
Treated floor area: 719,4 m²		Requirements

Annual heating demand: 228 kWh/(m²a)		25 kWh/(m²a)	
Fulfilled?*		no	
W/m²		Space heating	
kWh/(m²a)		Heating load: 123	
W/m²		Space cooling	
%		Overall specific space cooling demand	
kWh/(m²a)		Cooling load	
kWh/(m²a)		Frequency of overheating (> 24 °C): 11,3	
kWh/(m²a)		Primary Energy	
1/h		DHW, space heating and auxiliary electricity	
		Specific primary energy reduction through solar electricity	
		Airtightness	
		Pressurization test result n <sub>50</sub> : 4,0	
EnerPHit building retrofit (acc. to heating demand)?			
Registration number PHPP:			
Signature:			
Name:			
Surname:			
Company:			
Issued on:

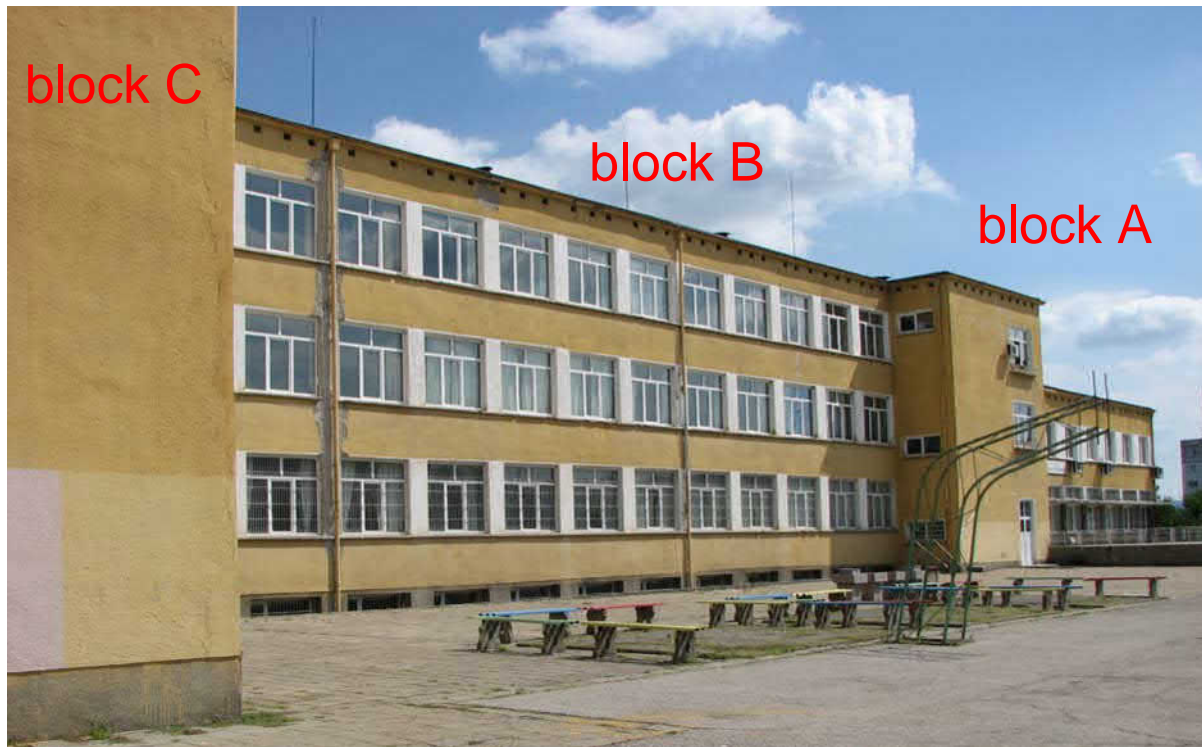
Figure 7: View towards Block A and Block B

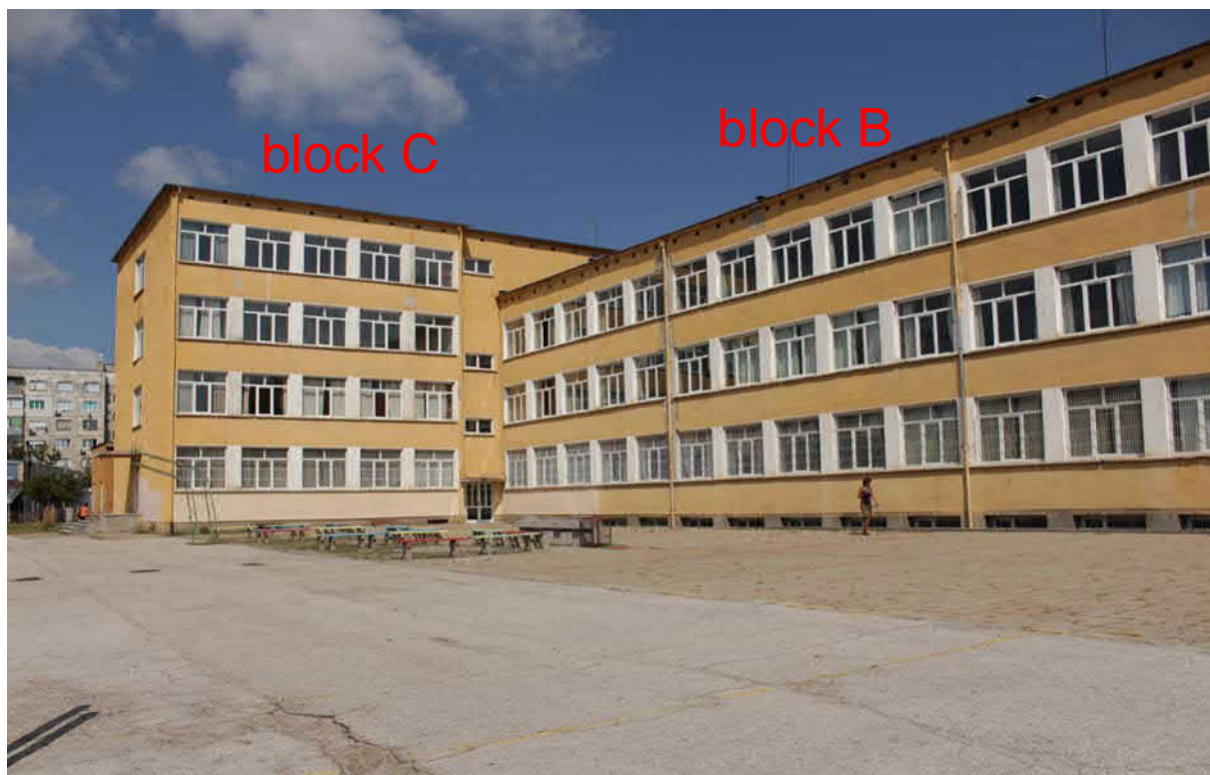
Figure 8: View towards Block B and Block C

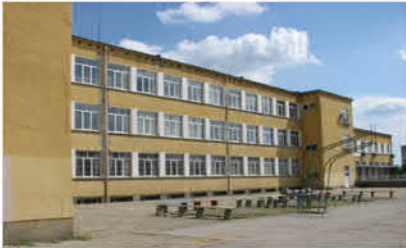
Building: Primary School 8 "Sveti Sveti Kiril I Street: 69 Mogilov blv. Postcode/City: Gabrovo Country: Bulgaria Building type: School Climate: Велико Търнов Altitude of building site (in [m] above sea level): 426			
		Home owner/client: Municipality of Gabrovo Street: 3 Vazrazhdane square Postcode/City: Gabrovo			
		Architecture: Mechanical System:			
		Street: Postcode/City: Energy consulting: Street: Postcode/City: Certification: Street: Postcode/City:			
		Year of Construction: 2014 Number of dwelling units: 1 Number of Occupants: 680,0 Exterior vol. $V_{e,}$ : 15290,3 m <sup>3</sup>		Interior temperature winter [C°]: 20,0 Internal heat gains winter [W/m²]: 2,8 Interior temp. summer: IHG summer [W] Spec. capacity [Wh/K per m² T] Mechanical cool	
		[C°]: 25,0 [m²]: 2,8 FA: 204 ing:			
Specific building demands with reference to the treated floor area					
Treated floor area: 4630,4 m² Annual heating demand: 44 kWh/(m²a)		Requirements: 25 kWh/(m²a)

Space heating:		Heating load: 26 W/m²			
Space cooling:		Overall specific space cooling demand: kWh/(m²a) Cooling load: W/m² Frequency of overheating (> 25 °C): 5,2 %			
Primary Energy:		121 kWh/(m²a) DHW, space heating and auxiliary electricity: 95 kWh/(m²a) Specific primary energy reduction through solar electricity: kWh/(m²a)			
Airtightness:		Pressurization test result $n_{50}$ : 2,0 1/h			
I confirm that the values given herein have been determined following the PHPP methodology and were determined based on the characteristics of the building. The PHPP calculations are attached to this application.					
Company: Registration number PHPP:		Name: Surname:			
Signed on: Signature		C: Is:

Figure 13: Specific energy efficiency values after measures within EuroPHit, Blocks A,B,C

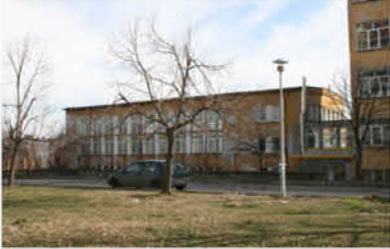
Building: **Primary School 8 "Sveti Sveti Kiril i Metodij"**

step	Year	BLOCK A,B,C	Specific Heating Demand	Specific Primary Energy Demand
existing situation		Constructed in 1970, no insulation, roof in bad conditions, from 2005 -new PVC windows in blocks A,B,C and new aluminum windows in block D (the gym). Since 2013, the school is connected to the central gas heating.	142,4	233,5
STEP 1	2015	Roof insulation above the last floor slab	111	196,4
STEP 2	2015	external wall insulation, new kitchen appliances and DHW - solar panels in block B, shading blockC airtightness , ventilation, reducing thermal bridges-cutting canopies and stairs	50.5	117,0

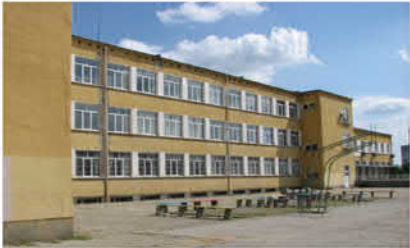
Building: Primary School 8 "Sveti Sveti Kiril I"	
		Street: 69 Mogilov blv.	
		Postcode/City: Gabrovo	
		Country: Bulgaria	
		Building type: School	
		Climate: Велико Търнов	
		Altitude of building site (in [m] above sea level): 426	
Home owner/client: Municipality of Gabrovo		Street: 3 Vazrazhdane square	
		Postcode/City: Gabrovo	
Architecture:		Mechanical System:	
Street:		Street:	
Postcode/City:		Postcode/City:	
Energy consulting:		Certification:	
Street:		Street:	
Postcode/City:		Postcode/City:	
[C°] 25,0	Year of Construction: 2014	Interior temperature winter [C°] 20,0	Interior temp. summer
[m²] 2,8	Number of dwelling units: 1	Internal heat gains winter [W/m²] 2,8	IHG summer [W]
FA 204	Number of Occupants: 680,0		Spec. capacity [Wh/K per m² T
ing:	Exterior vol. V <sub>e</sub> : 15290,3 m³		Mechanical cool
Specific building demands with reference to the treated floor area

Fulfilled?*	Space heating	Treated floor area 4630,4 m²	Requirements 25 kWh/(m²a)
yes	Annual heating demand 17 kWh/(m²a)		
-	Heating load 13 W/m²		
-	Space cooling Overall specific space cooling demand kWh/(m²a)

For an overview of the energy efficiency of the completed step-by-step refurbishment, see the verification spreadsheet of the PHPP 9 beta version [PHI 2013] on the next page.
