## D3.9\_Overall Refurbishment Plan

**CS12**

**Stockholm**

[Improving the energy performance of step-by-step refurbishment and integration of renewable energies]

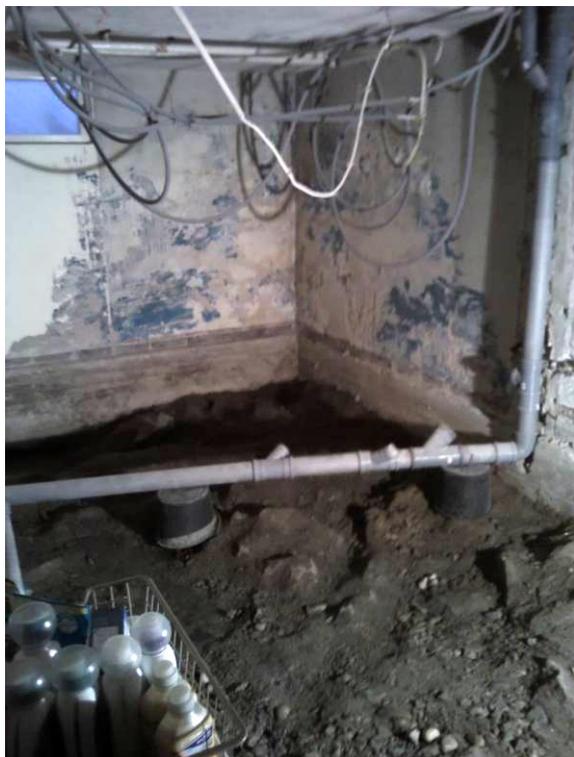
Figure 4: Lower floor dug up/concrete removed

- Description: Uninsulated concrete slab on rock.
- U-Value: 3.9 W/(m<sup>2</sup>·K)
- Installation date: 1954
- Condition: In the process of being taken out
- Next replacement: Within the next months
- Other: The rock underneath is partially chisled out as well in order to allow for the addition of insulation and installation of radon-gas-shielding.

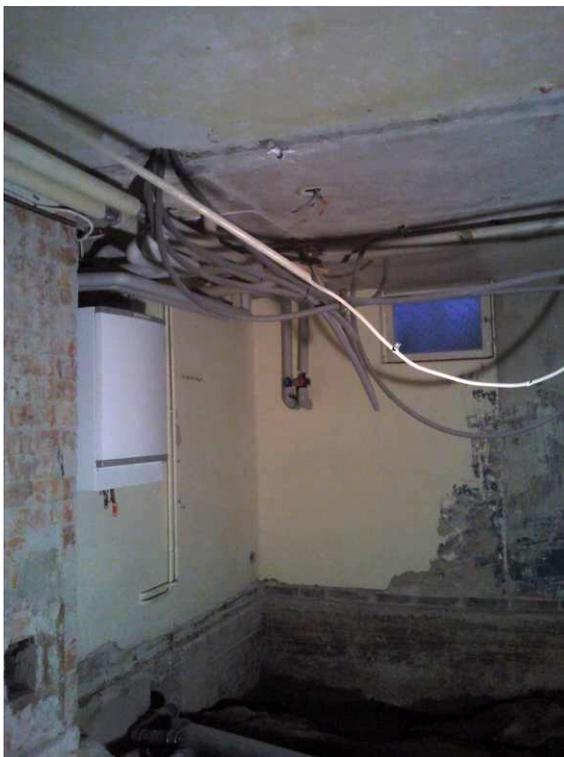
Figure 5: New district heat station

- Description: District heat; x-station in lower floor level; central heating
- Efficiency: approx. 95%
- Installation date: Station recently, radiators 1954 (?)
- Condition: As-new, serviceable.
- Next replacement: Not planned
- Other: Since the heating load will be reduced, some of the radiators might be removed

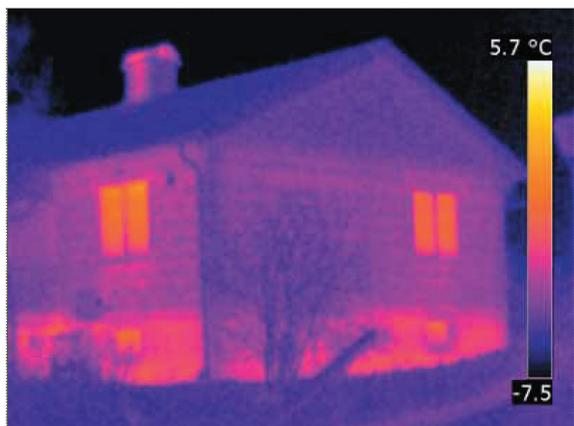
Figure 6: Thermal picture, view from SE
