Step-by-step towards EnerPHit-Standard retrofit

Relevance of typical thermal bridges in a detached Franconian house from 1959

Hochschule Hannover /
University of Applied Sciences and Arts
Master Programme
Nachhaltiges Energie-Design für Gebäude /
Sustainable Energy Design for Buildings
Master Thesis, winter semester 2014/2015

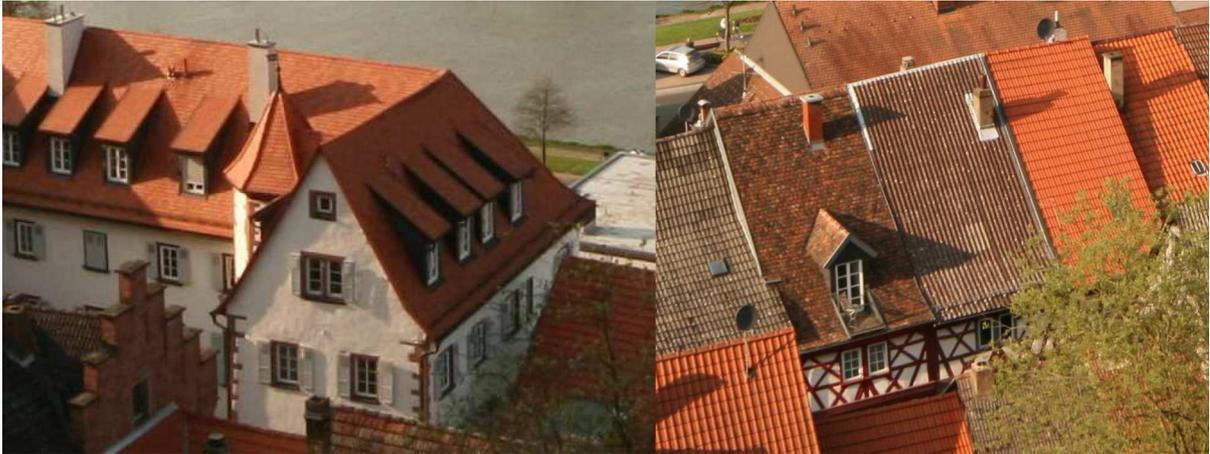
Although not a traditional lattice construction with eaves laths, known as “The Franconian construction style”, see Figure 5, the Sonnenstrasse building type was reproduced in nearly every Franconian settlement. Thus, demonstrating sustainable solutions for it will be beneficial for many other potential retrofits.

Figure 5: Typical Franconian buildings in lattice construction with and without render finish, Miltenberg, Germany. Source: Jose Alonso

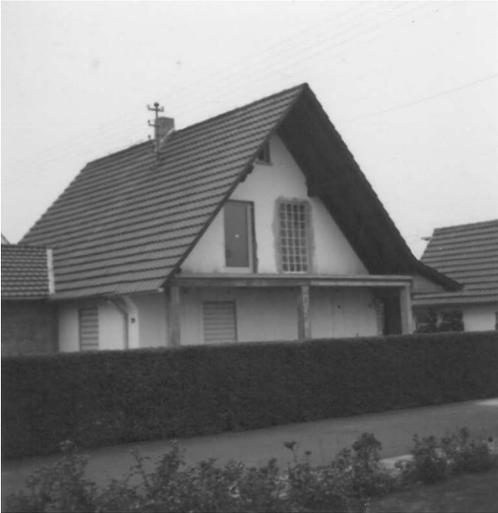
Figure 6: Additions to the original design. Balcony and glass block element. Source: Karl Theumer

- Concrete balcony and access door as well as enlargement of the former window and use of glass bricks, see Figure 6
- Entrance porch added, see Figure 7
- Living room extension added with larger window areas, see Figure 8
- Wooden window frames and double-glazing replaced by PVC windows with double-glazing, new bathrooms, new floor finishes
- Bigger dormer windows added

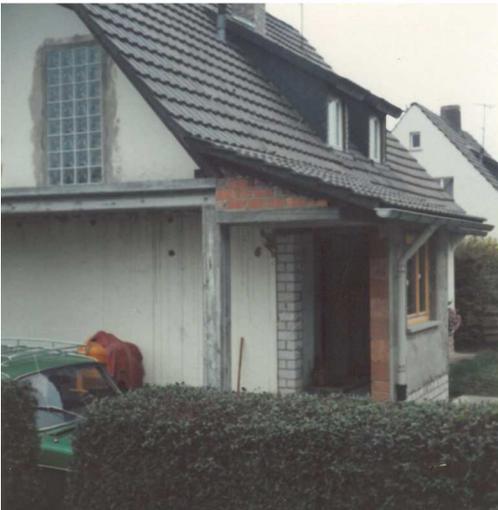
Figure 7: Additions to the original design. Entrance porch. Source: Karl Theumer

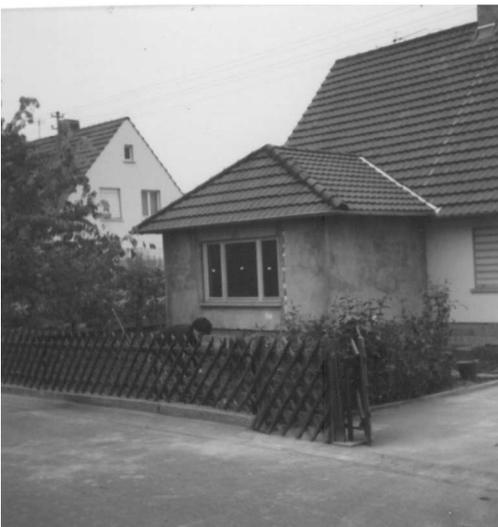
Figure 8: Additions to the original design. Living room extension. Source: Karl Theumer

- 1974: Concrete balcony and access door as well as enlargement of the former window and use of glass bricks, entrance porch added. Living room extension added with larger window areas (1974), see Figure 8.

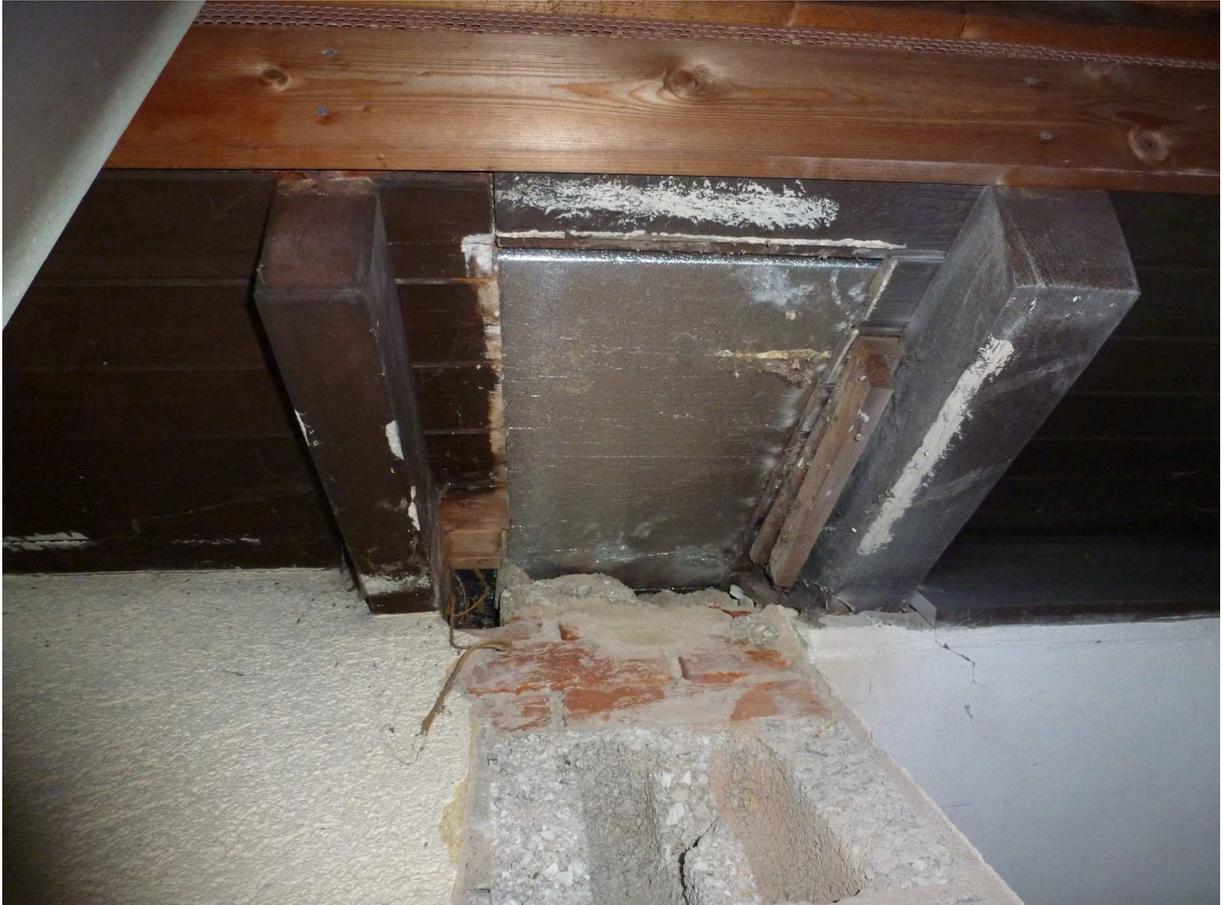
Figure 11: Eaves connection is not airtight. Provision should have been made to close the leakages. Instead, the timber (not airtight) joints were sealed. Source: Karl Theumer

the airtight connection of the roof and wall airtightness layers, which was not properly addressed, see Figure 11.

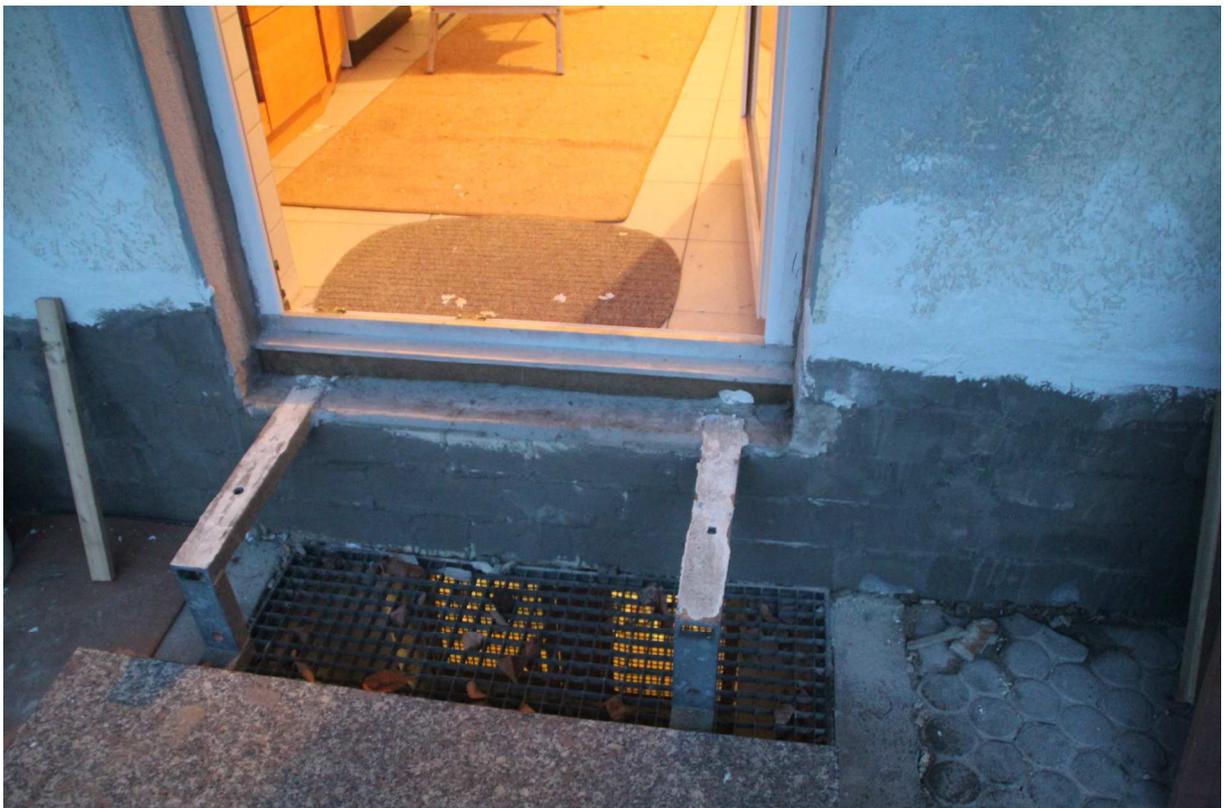
Figure 16: Kitchen access. Source: Karl Theumer

The decision in 1999 to have a direct access from the kitchen to the garden resulted in the detail shown in Figure 16, with two thermal bridges just at the bottom of the door.

According to the table on page 79 and corresponding photograph on page 87 in [PHI-RG35], the linear thermal bridge effect was estimated to be 0.05 W/(K) for each penetration and considered in the PHPP energy balance. A 3D calculation would have been necessary to determine the exact thermal bridge effect of the detail both without and with external wall insulation. This is outside of the scope of this master thesis.
