CS14_Wilmcote House_United Kingdom

1.1.3 Garden side jamb

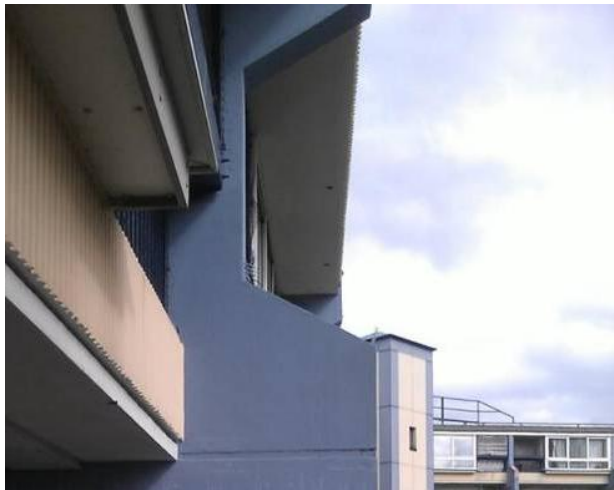
BEFORE

1.1.3 Garden side jamb – site photo
