EuroPHit_OP24_ZEPHIR_La Provvidenza_Italy

BWEJ Concrete columns on the basement floor slab

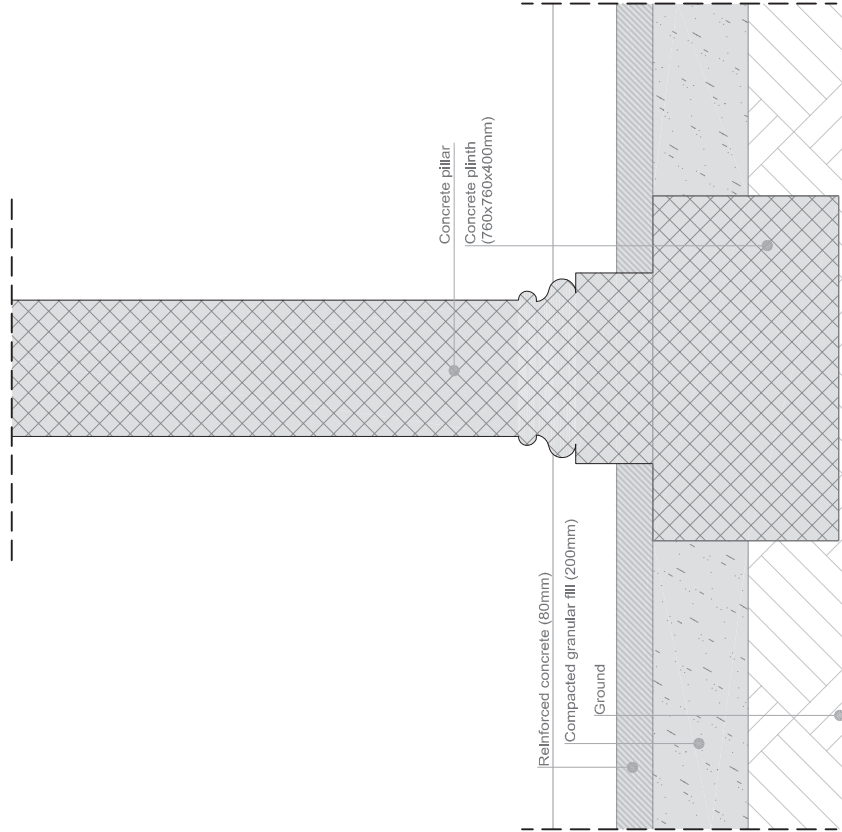
EXISTING

The existing concrete slab was taken off and replaced adding PIR insulation. In the refurbishment step, it was impossible to remove completely the thermal bridge in correspondence of the structural columns, so the purpose has been to minimize it. The absence of mould and condensation formation has been verified.

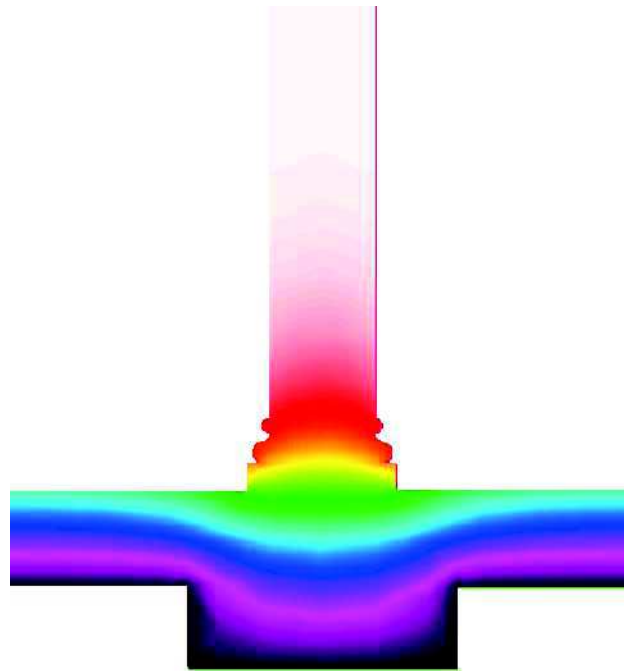
EXISTING

L2D = 13,6797 W/mK

$\Psi = -0,063$ W/mK

The existing concrete slab was taken off and replaced adding PIR insulation. In the refurbishment step, it was impossible to remove completely the thermal bridge in correspondence of the structural columns, so the purpose has been to minimize it. The absence of mould and condensation formation has been verified.

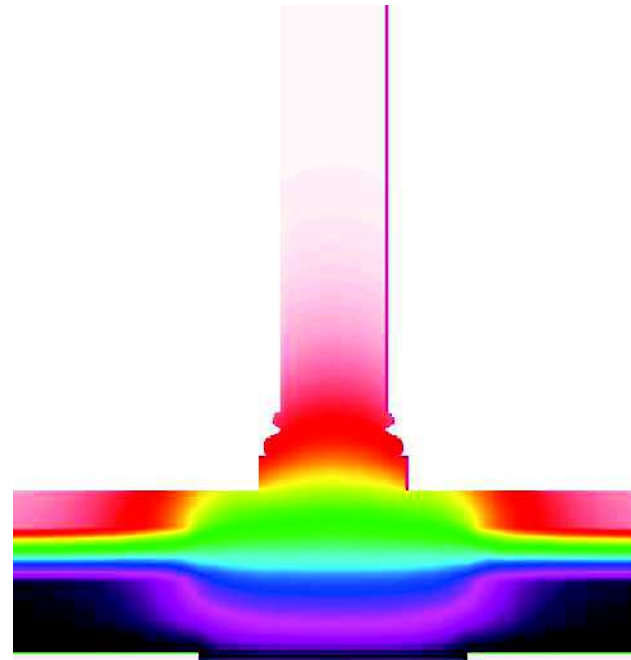
FINAL STEP

L2D = 3,1788 W/mK

$\Psi = 2,488$ W/mK

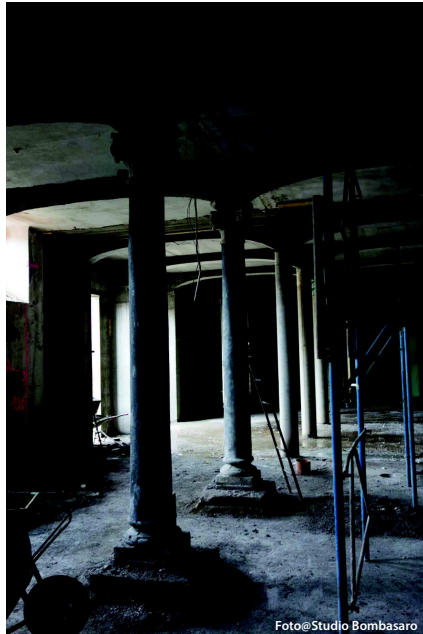
BEFORE

The existing concrete slab was taken off and replaced adding PIR insulation. In the refurbishment step, it was impossible to remove completely the thermal bridge in correspondence of the structural columns, so the purpose has been to minimize it. The absence of mould and condensation formation has been verified.
