EuroPHit_OP24_ZEPHIR_La Provvidenza_Italy

BW/W | Structural internal wall on basement floor slab

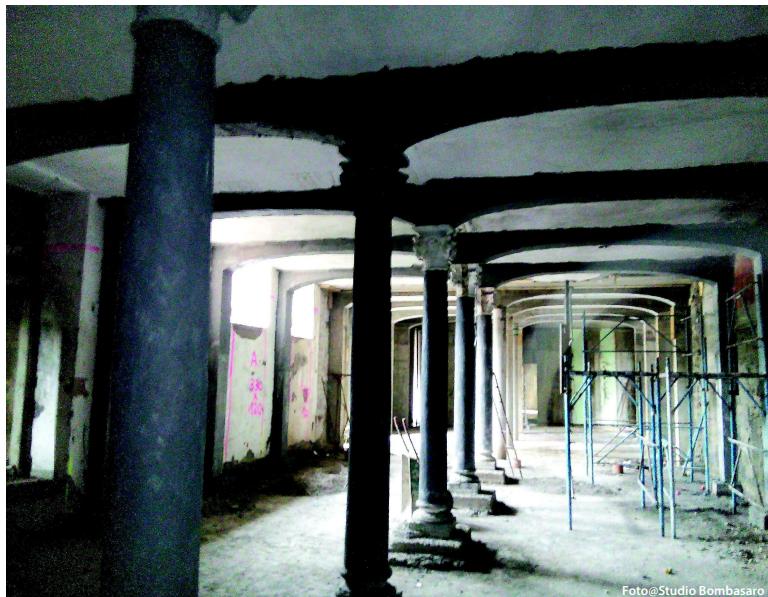
BEFORE

The entire basement slab in contact with the ground was replaced adding a PIR insulation. In correspondence of structural elements (pillars and internal walls) it was impossible to guarantee the continuity of the insulation layer, therefore they have been considered as punctual and linear thermal bridges. The absence of mould and condensation formation has been verified.
