EuroPHit_OP24_ZEPHIR_La Provvidenza_Italy

FSEW01 Basement stone wall - floor slab connection

Author ZEPHIR

Date 29.03.2016

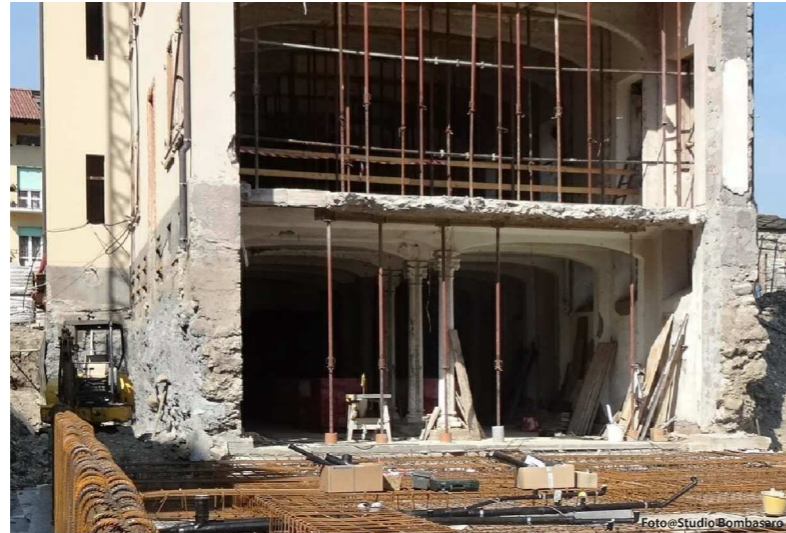
BEFORE

The entire basement slab in contact with the ground was replaced and insulated with PIR panels. The stone wall was insulated with XPS panels. On the connection point a significant interruption of the insulation layer is caused by the existing structural stone wall. The addition of a thermal break element was hard to implement and not reasonable from an economical point of view. The absence of mold and condensation formation has been verified.
