EuroPHit_OP24_ZEPHIR_La Provvidenza_Italy

ROEA Eaves detail for masonry wall

ROEA Eaves detail for masonry wall - THERM

ROEA Eaves detail for masonry wall - Site photo

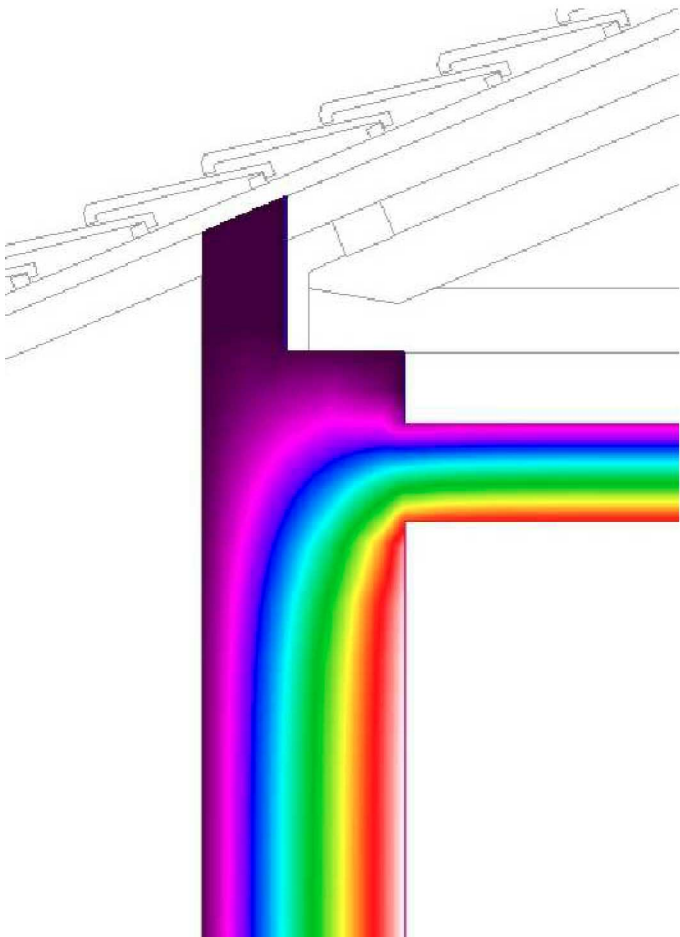
EXISTING

L2D = 8,541 W/mK
 $\Psi = -0,219$ W/mK

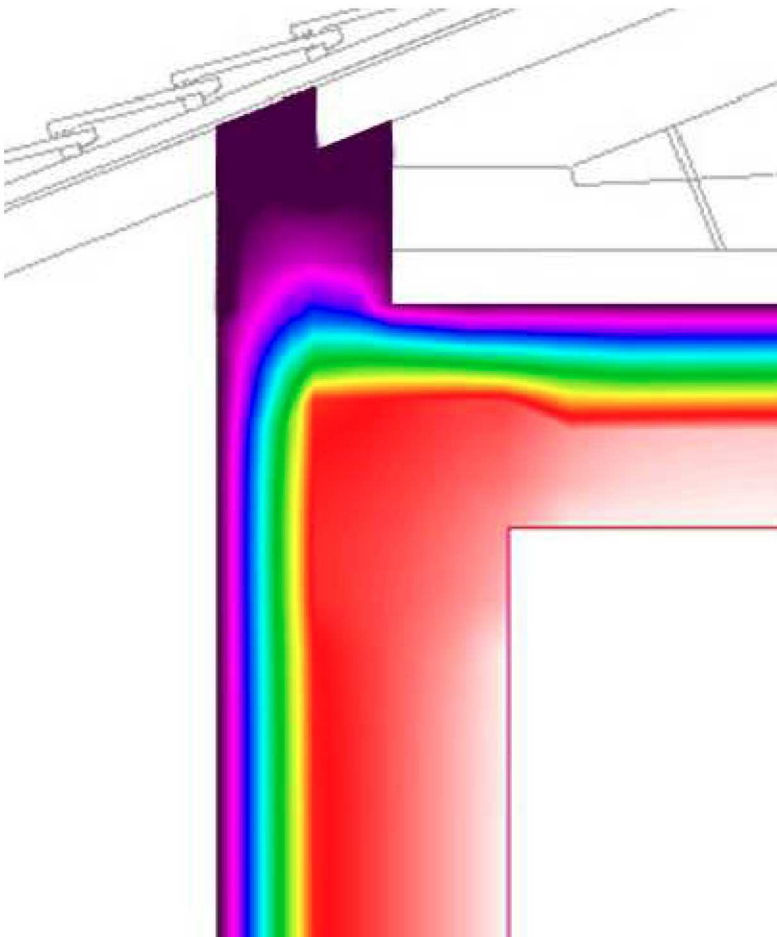
FINAL STEP

L2D = 0,7276 W/mK
 $\Psi = 0,024$ W/mK

On the existing concrete and masonry slab, the airtight layer was restored through poured in place concrete. On the wall a new layer of interior plaster has been applied in order to guarantee the same function. The entire wooden roof was removed and rebuilt to minimize the thermal bridge. The thickness of the timber ring beam was reduced in order to reduce the interruption of the insulation layer.

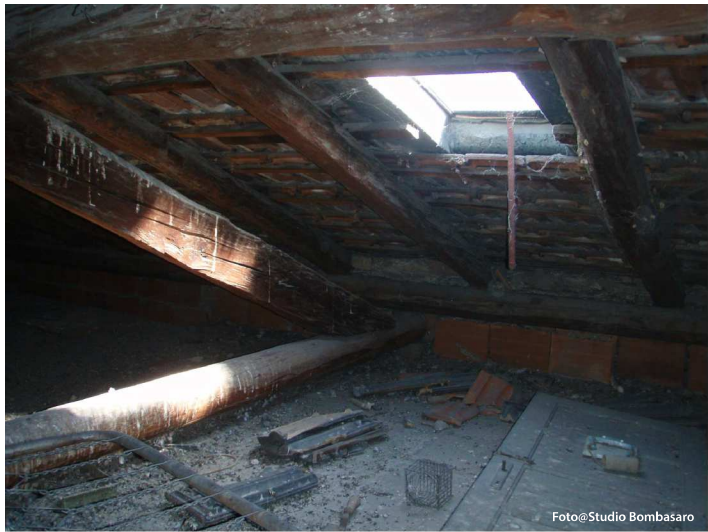
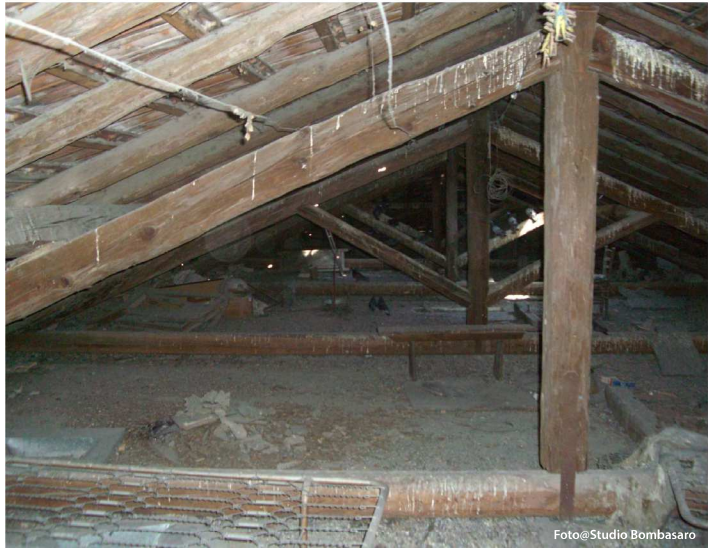
BEFORE

On the existing concrete and masonry slab, the airtight layer was restored through poured in place concrete. On the wall a new layer of interior plaster has been applied in order to guarantee the same function. The entire wooden roof was removed and rebuilt to minimize the thermal bridge. The thickness of the timber ring beam was reduced in order to reduce the interruption of the insulation layer.
