EuroPHit_OP24_ZEPHIR_La Provvidenza_Italy

Window sill for a massive wall - Site Photo

Scale -Author ZEPHIR Date 11.03.2015

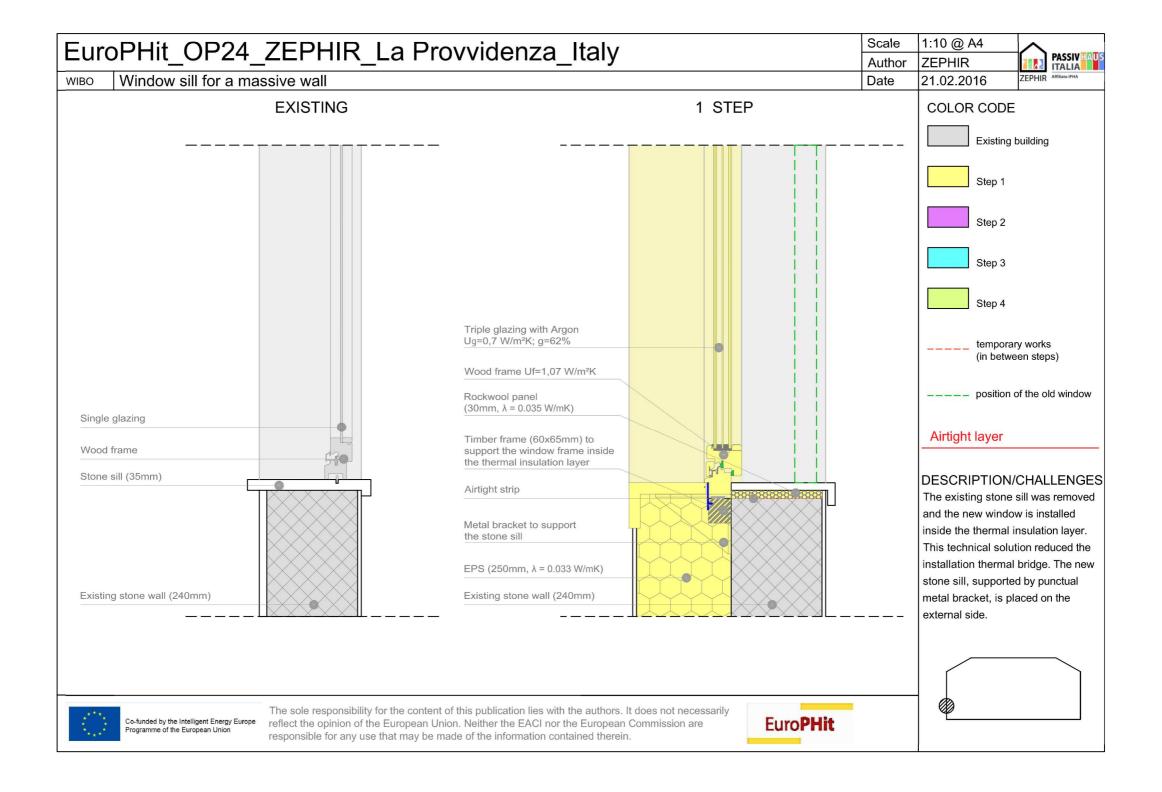
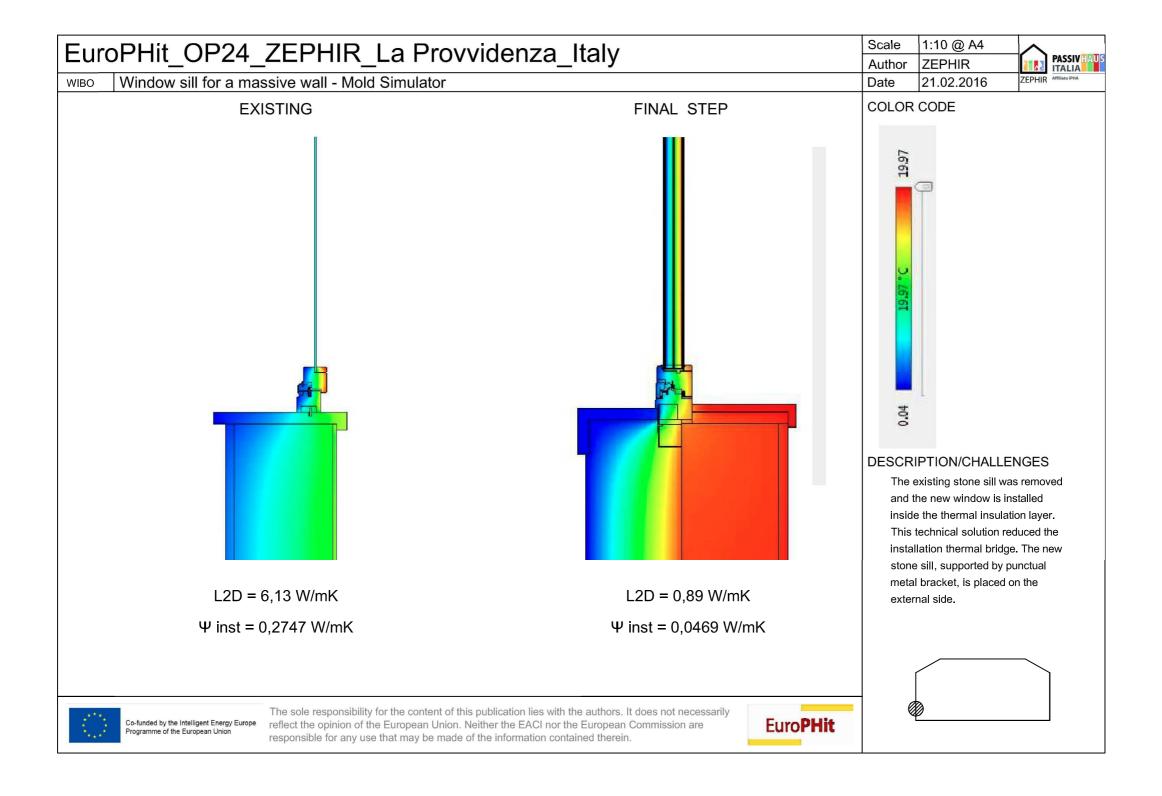
The existing stone sill was removed and the new window is installed inside the thermal insulation layer. This technical solution reduced the installation thermal bridge. The new stone sill, supported by punctual metal bracket, is placed on the external side.
