# CS14\_Wilmcote House\_United Kingdom

## 1.1.2 Street side Sill

Date March 2015

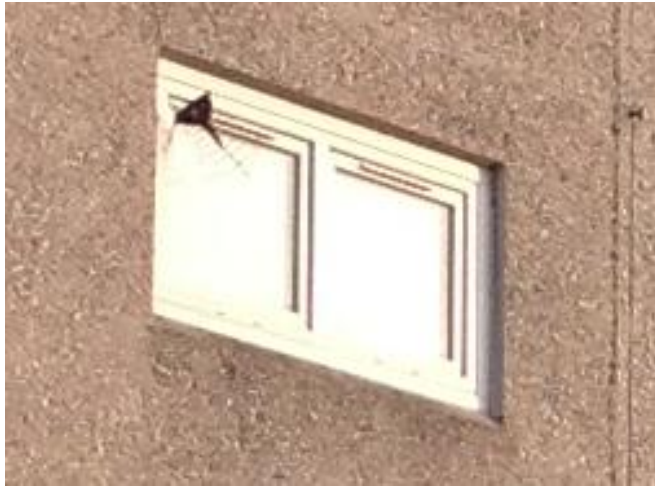
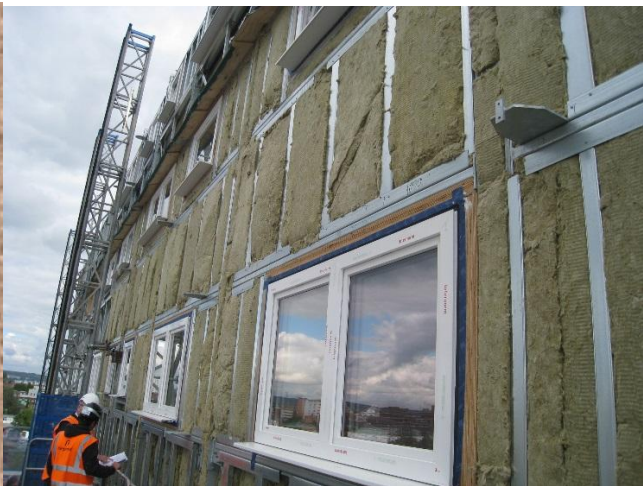
1.1.2 Street side Sill – site photo

BEFORE

AFTER

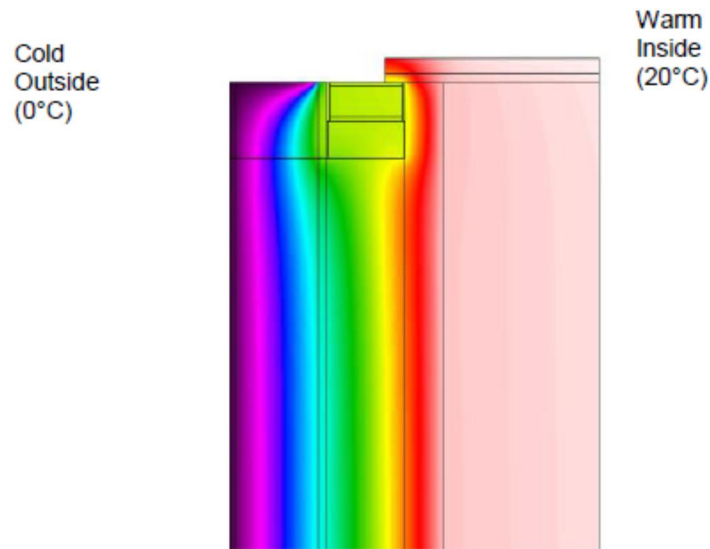
## 1.1.2 Street side Sill – Thermal model

FINAL STEP

$\Psi$ -value = 0.07 W/mK

No pre-refurbishment thermal modelling undertaken
