CS14_Wilmcote House_United Kingdom

Author	Steven Stenlund	BRE
Date	March 2015

1.2.3 Main street side column fixing detail A

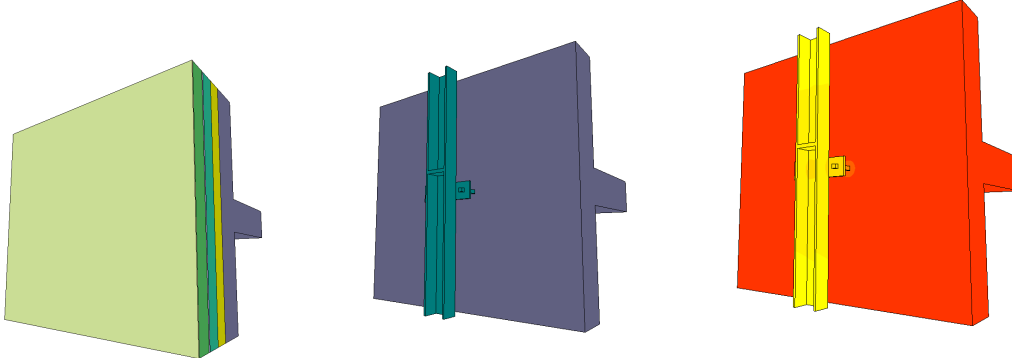
CS14_Wilmcote House_United Kingdom		Author	Steven Stenlund	BRE
1.2.3	Main street side column fixing detail A – Thermal model	Date	March 2015	
<p>No pre-refurbishment thermal modelling undertaken</p> <p>FINAL STEP</p>

<p>χ-value = 0.014 W/K (each bolt)</p>		<p>Colour code</p>
