CS14_Wilmcote House_United Kingdom

Author	Steven Stenlund	BRE
Date	March 2015

1.3.2 Street side Eaves

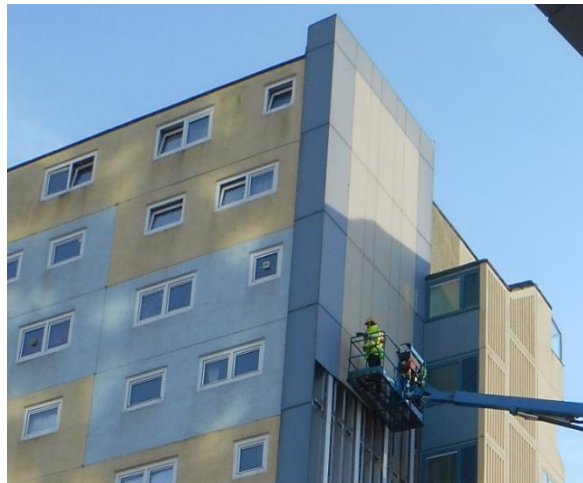
BEFORE

1.3.2 Street side Eaves – site photo

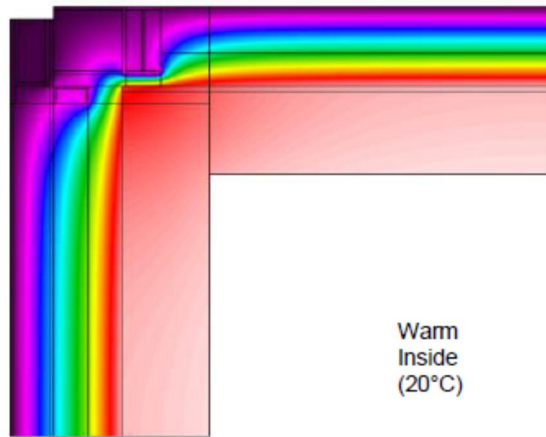
1.3.2 Street side Eaves – Thermal model

Isotherms

(Lines of constant temp)

Cold Outside
(0°C)

Warm Inside
(20°C)

$$\Psi\text{-value} = 0.03 \text{ W/mK}$$
