CS14_Wilmcote House_United Kingdom

Author	Steven Stenlund	BRE
Date	March 2015

1.1.1 Street side Jamb

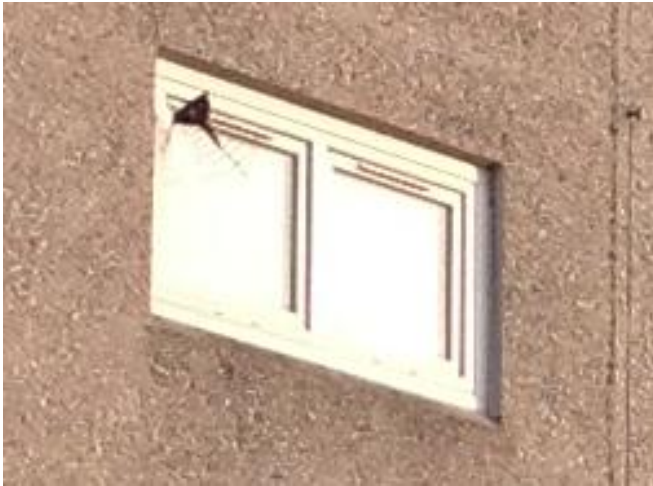
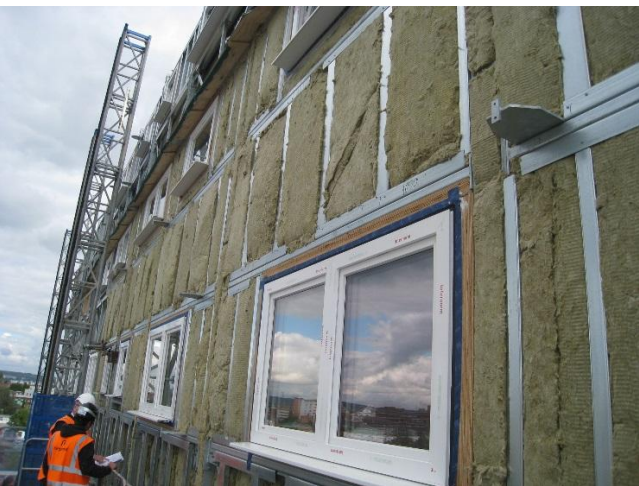
1.1.1 Street side Jamb – site photo

BEFORE

AFTER

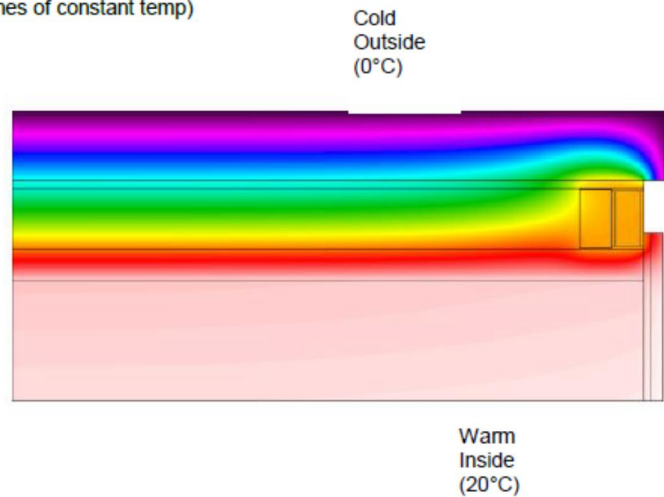
1.1.1 Street side Jamb – Thermal model

No pre-refurbishment thermal modelling undertaken

Isotherms

(Lines of constant temp)

Ψ -value = 0.03 W/mK
