CS14_Wilmcote House_United Kingdom

Author	Steven Stenlund	BRE
Date	March 2015

1.2.4 Street side main steel

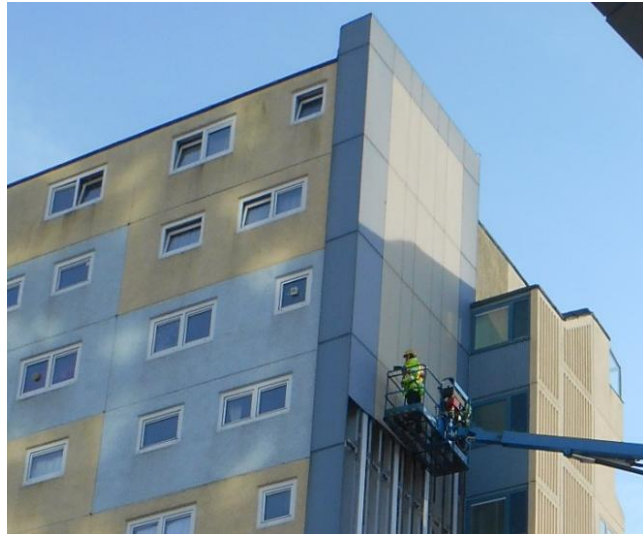
BEFORE

1.2.4 Street side main steel – site photo
