# EuroPHit

## D3.4\_PHPP Result Sheets

### CS13

### Næstved

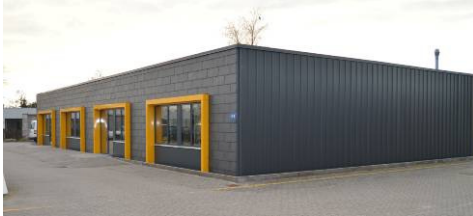
#### 3.1 PHPP Result Sheet of the completed refurbishment (2014)

Building: <b>Værksted</b>		Street: <b>Tommerupvej 8B</b>
	Postcode/City: <b>4700 Næstved</b>		Country: <b>Næstved</b>
	Building type: <b>Workshop/office</b>		Climate: <b>[DK] - København</b>
	Altitude of building site (in [m] above sea level): <b>-</b>		
	Home owner/client: <b>Næstved Kommune</b>		Street: <b>Rådmandshaven 20</b>
	Postcode/City: <b>4700 Næstved</b>		Mechanical System: <b>Passivhus.dk ApS</b>
	Street: <b>Fælledvej 21, Rønnebæk</b>		Street: <b>Heksehøjen 5B</b>
	Postcode/City: <b>4700 Næstved</b>		Postcode/City: <b>4700 Næstved</b>
	Energy consulting: <b>Passivhus.dk ApS</b>		Certification:
	Street: <b>Heksehøjen 5B</b>		Street:
Postcode/City: <b>4700 Næstved</b>		Postcode/City:	
Year of Construction:	<b>2014</b>	Interior temperature winter [C°]	<b>20,0</b>
Number of dwelling units:	<b>1</b>	Interior temp. summer [C°]	<b>25,0</b>
Number of Occupants:	<b>12,0</b>	Internal heat gains winter [W/m²]	<b>3,5</b>

Exterior vol. V <sub>e</sub> :	<b>731,5</b> m <sup>3</sup>	IHG summer [W/m²]	<b>3,5</b>
		Spec. capacity [Wh/K per m² TFA]	<b>204</b>
		Mechanical cooling:
