EuroPHit_OP25_IGPH_Stacken_Sweden

Upper floor walls

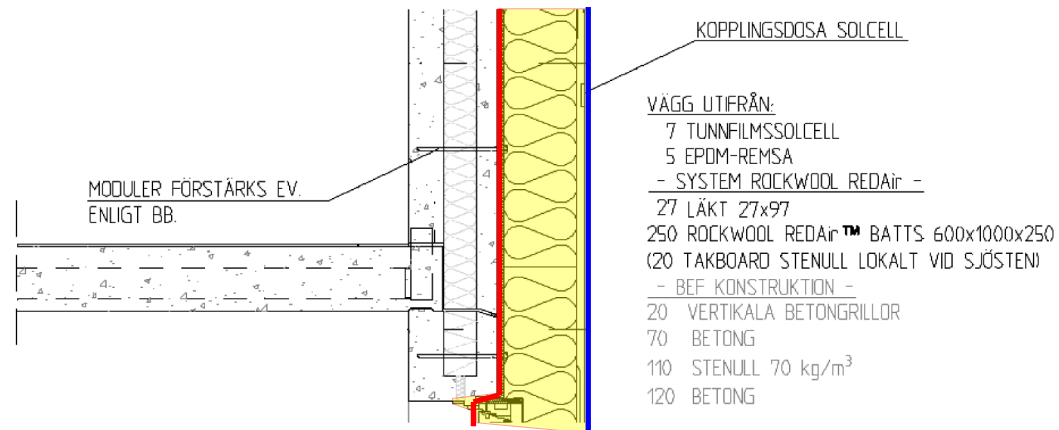
1 STEP

The upper floor walls are insulated and the BIPV facade fitted. The thermal bridge for the connection "intermediate ceiling-wall" is eliminated.
