Case Study_CS16_HouseCentón_Spain

FSPW Floor slab party wall. Vertical section.

FSPW | Floor slab party wall. Vertical section. - THERM

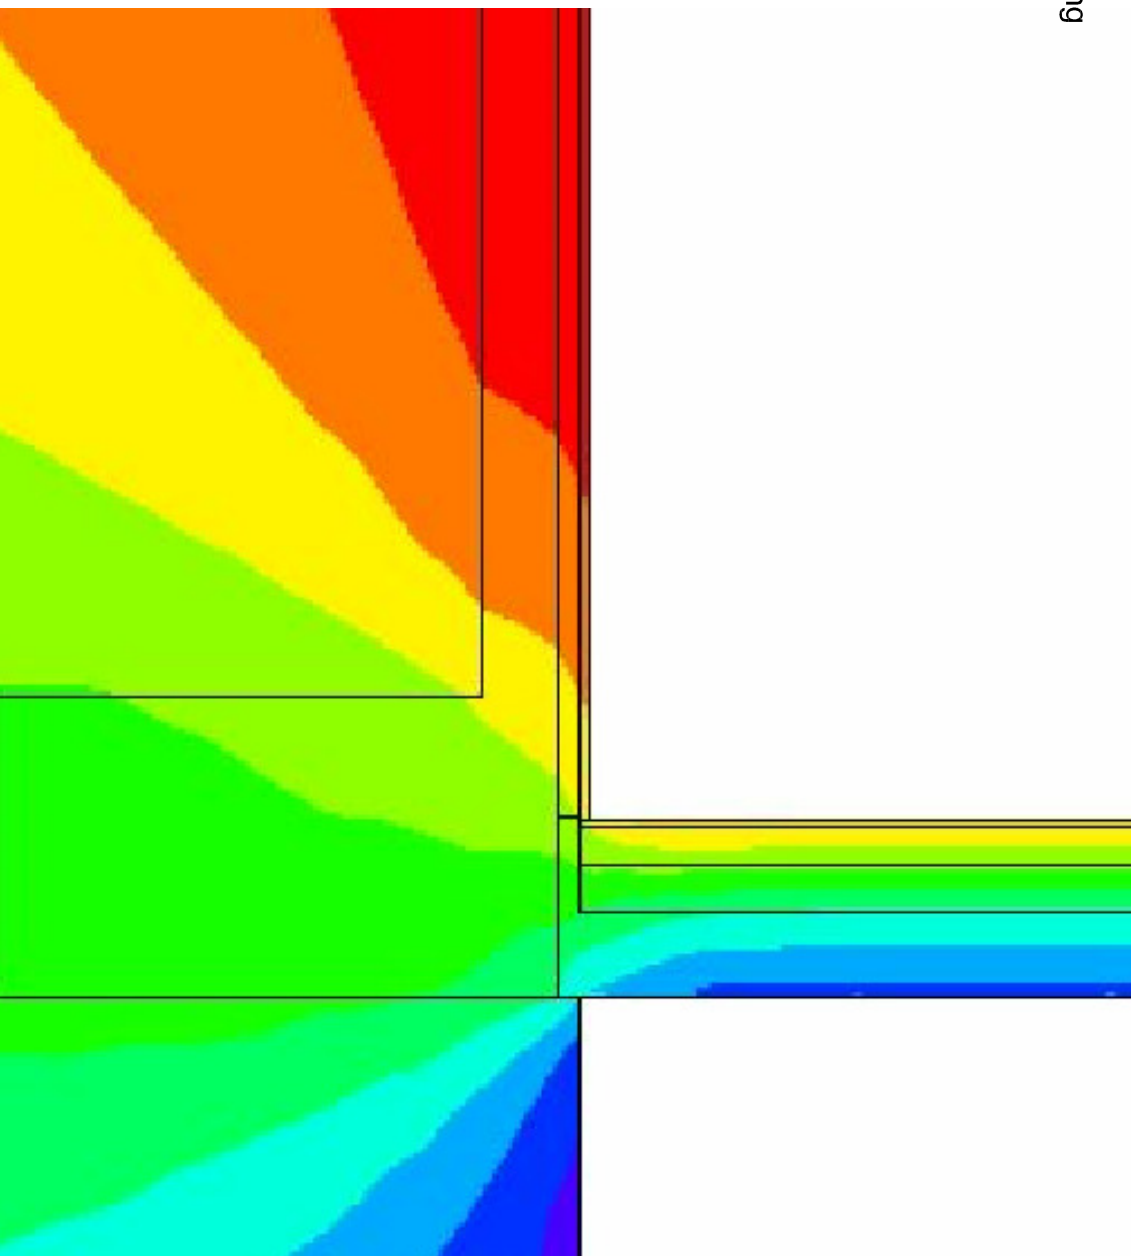
Existing

ψ - value [W/mK] = 0.035

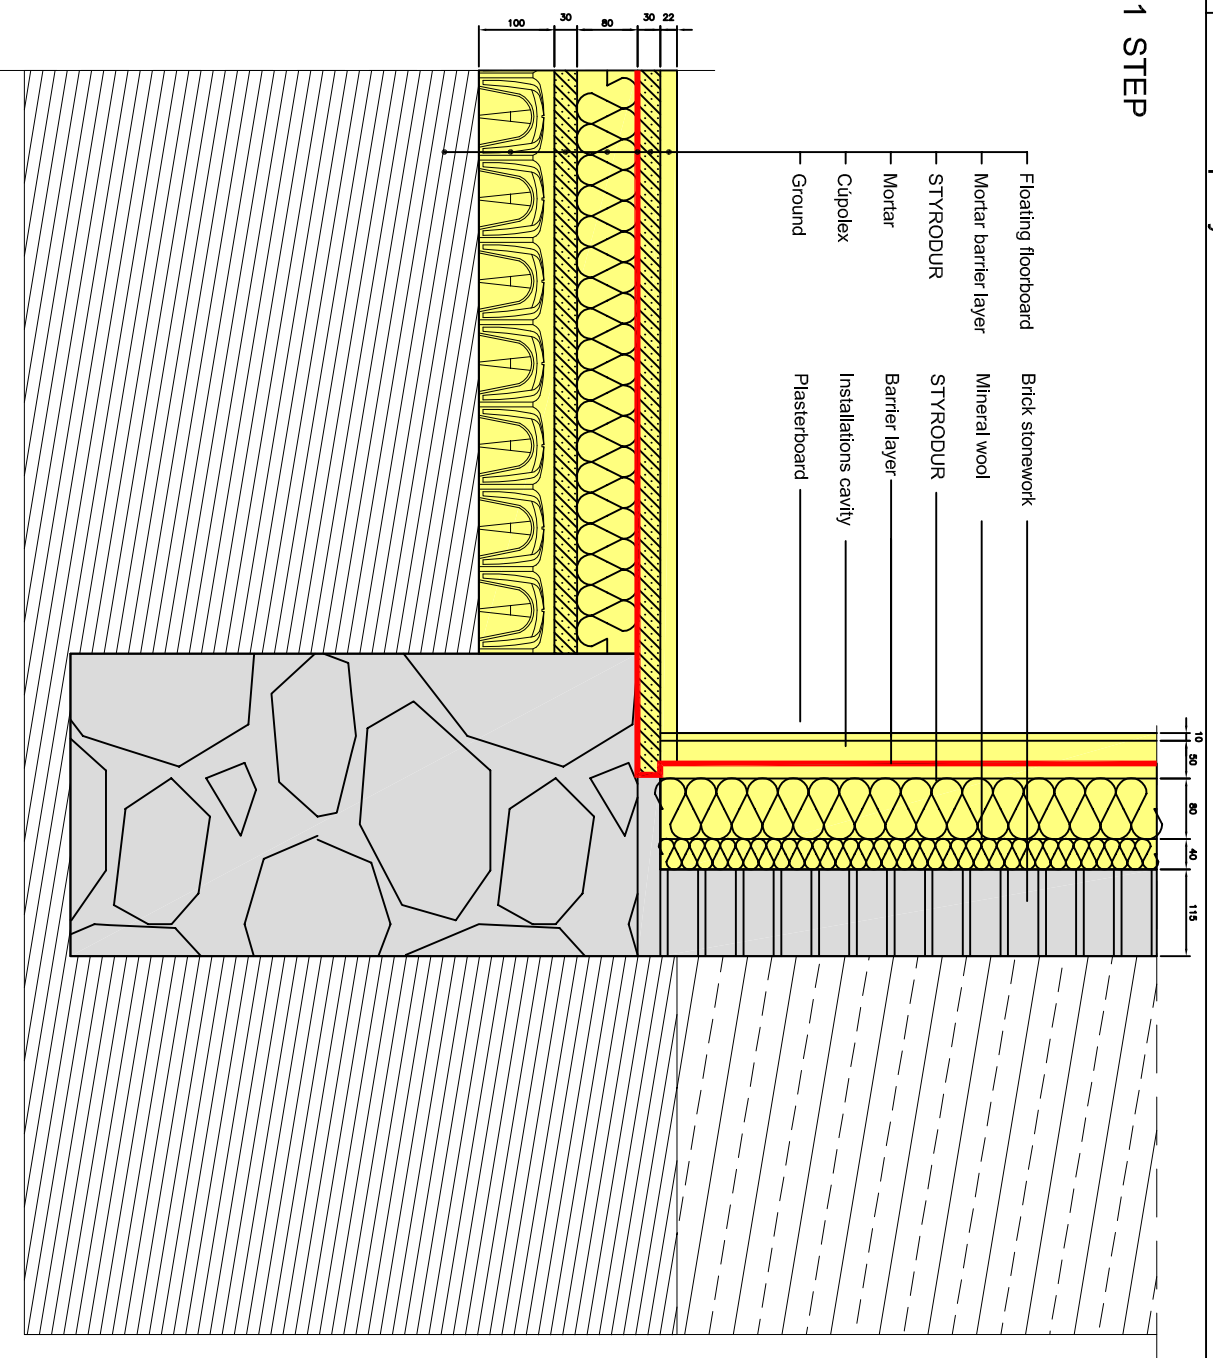
1 STEP

FSPW Floor slab party wall. Vertical section.

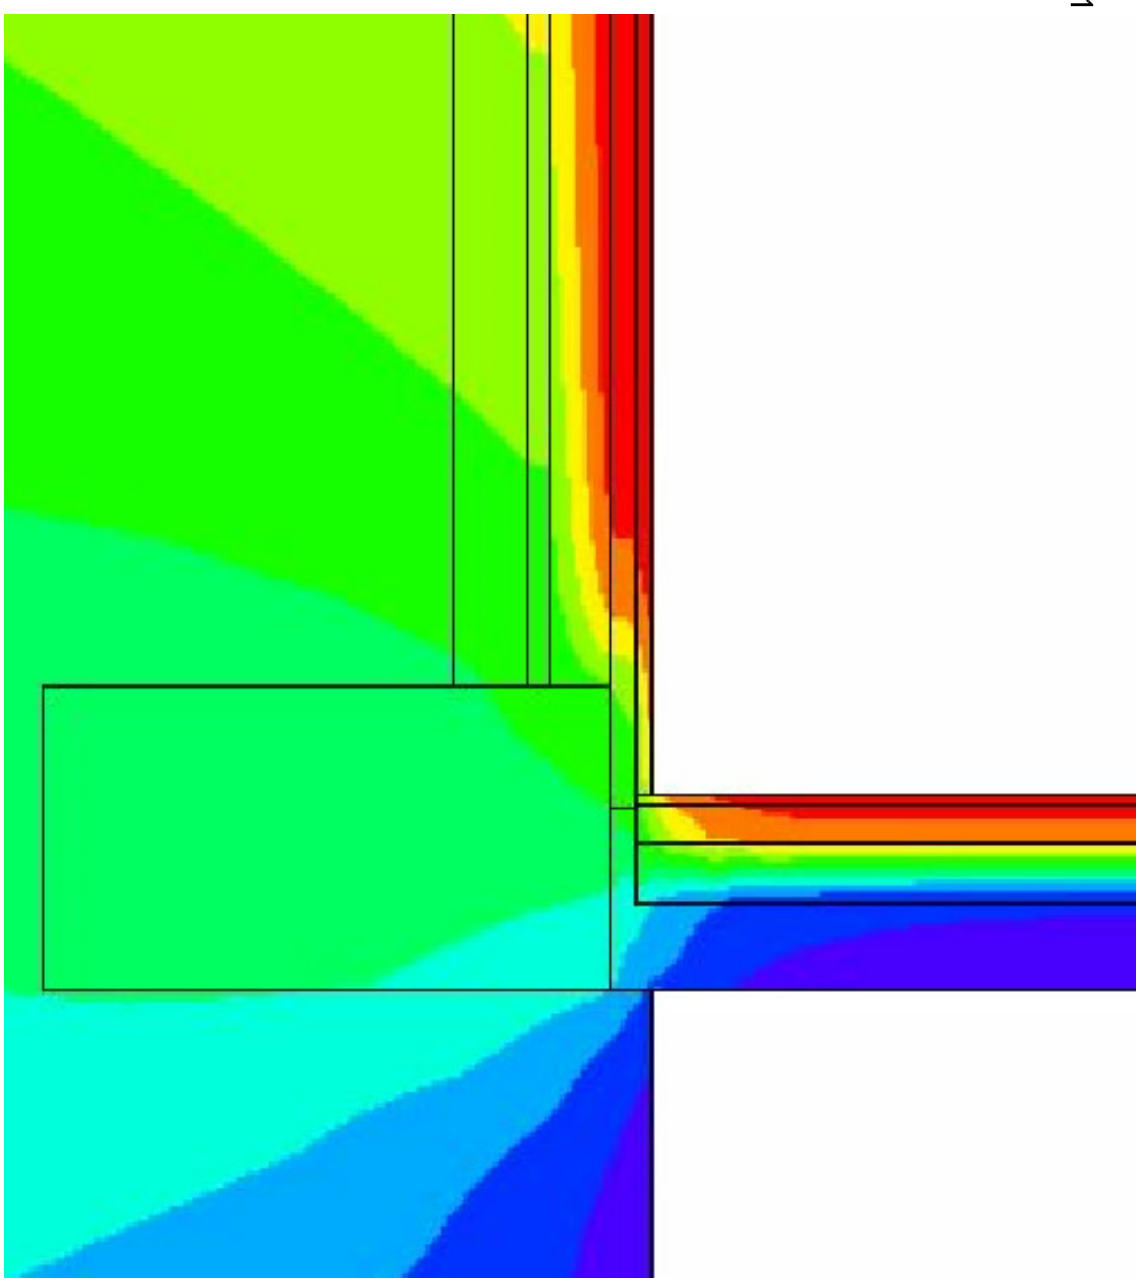
Step 1

FSPW | Floor slab party wall. Vertical section. - THERM

ψ - value [W/mK] = -0.165
